March 1, 2013

Re: Lake Merritt Pump Station Inspection
Oakland, California
MEG File No. 120469

Lake Merritt Pump Station
Inspected Component Locations
February 2013

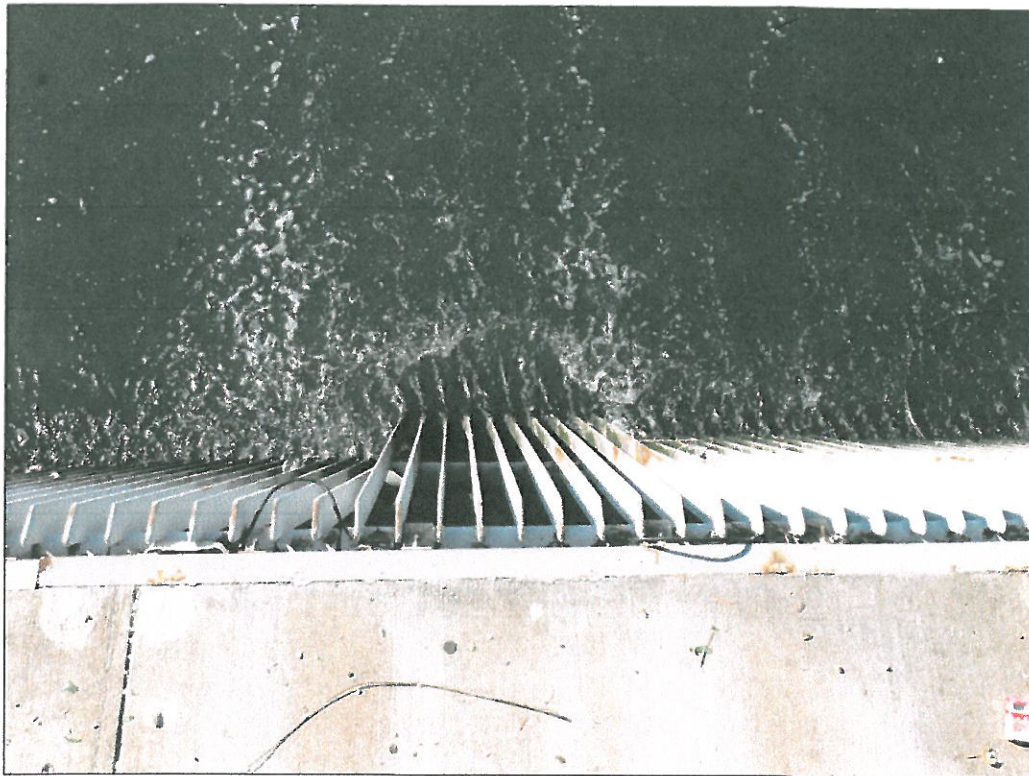
In the vicinity of the discharge flow on both Lakeside and Bayside, some Trash Rack sections do not return to rest on the toe curb as designed, but rather fall onto an adjacent rack. This permits a fairly large opening between adjacent racks for trash and other debris to transit into the pump impellers.

Downstream/Bayside Trash Rack Displaced by Discharge Flow

9. Adjust or Modify the Trash Racks to allow room for flow-current displaced racks to realign into their correct positions.

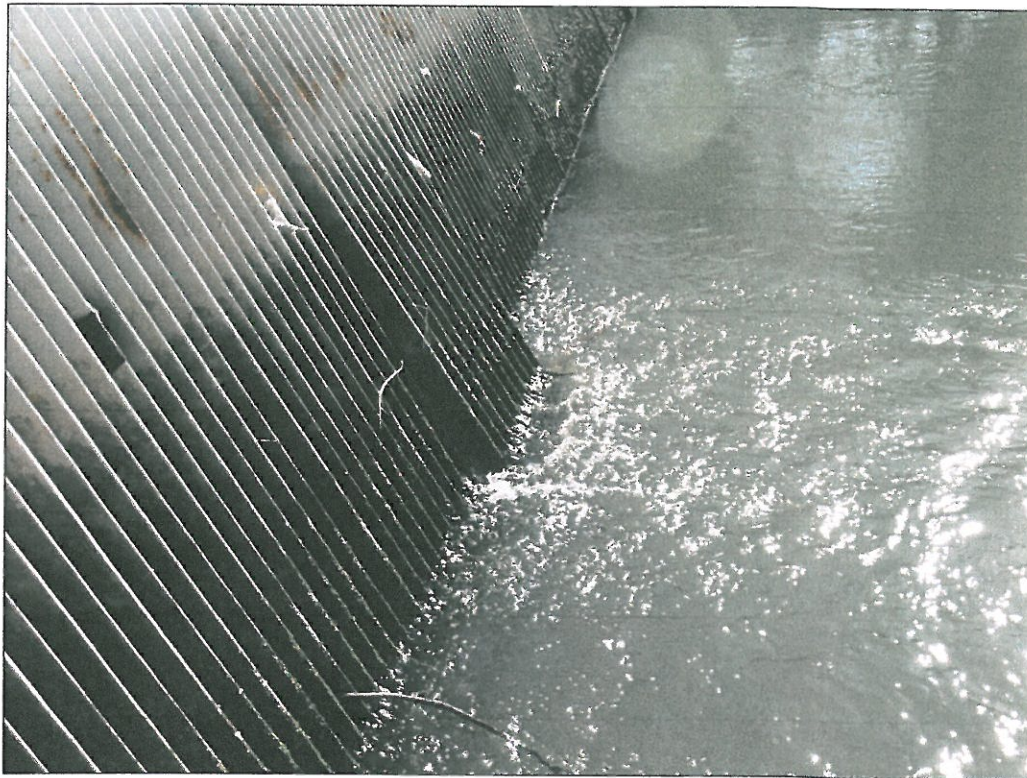
The Trash Racks have localized areas of corrosion where the existing ceramic coating system has failed. Although there is no imminent danger to the trash racks, if the corrosion is left to continue it will eventually degrade these elements.

Upstream/Lakeside Trash Rack Displaced by Discharge Flow
Also Areas of Coating Failure

8. Repair the protective coating system on the corroded areas of the Trash Racks. Comparison with photos taken during a routine visit in June 2011 shows a large increase of corroded area.

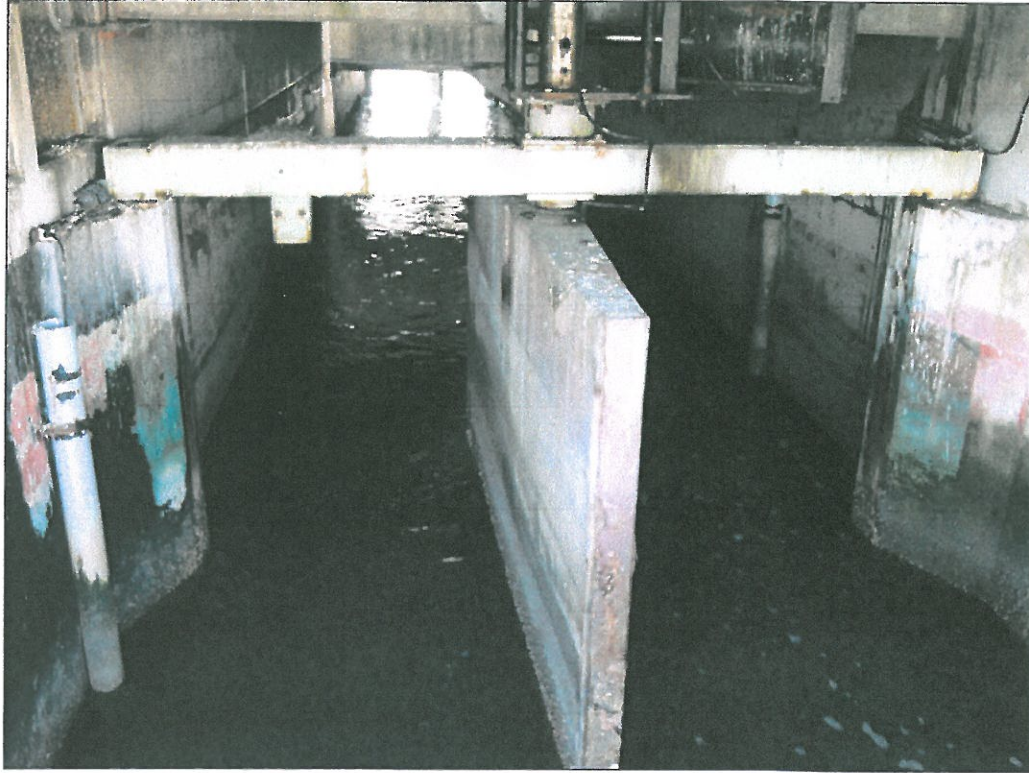
GS-1 Gate and Suction Channel
Typical Location of Gate Graphite Anodes

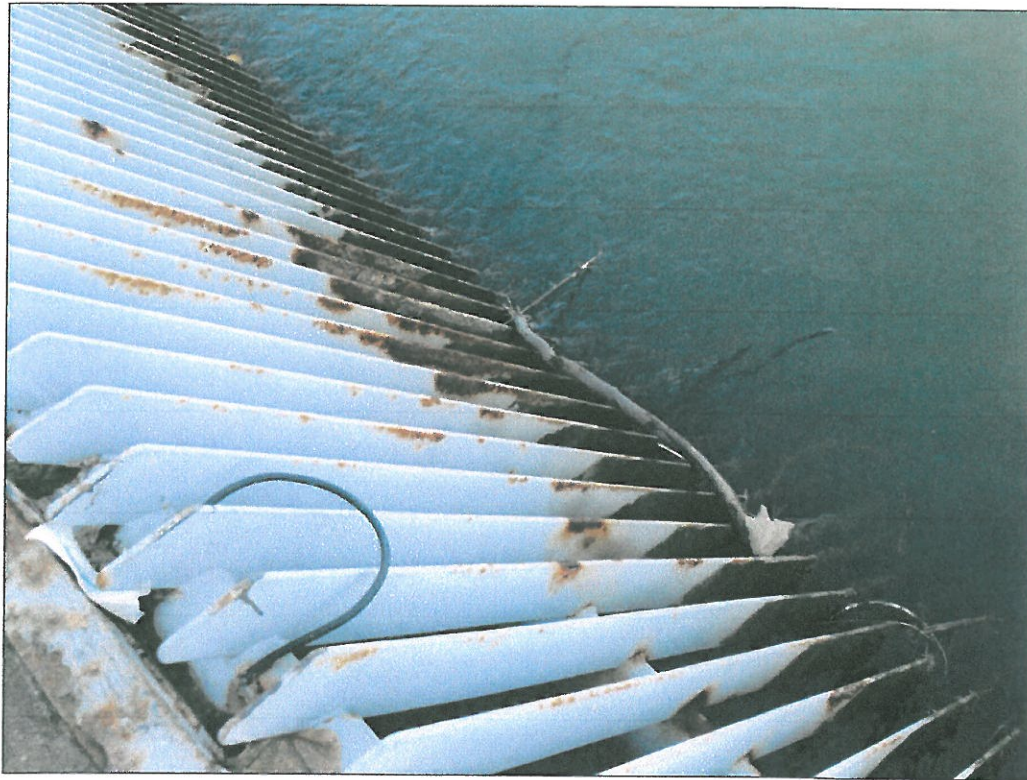
Upstream Trash Rack - Corrosion Example

5. Inspect the effectiveness of the Trash Rack coating system for additional signs of distress and possible coating failure. Determine if an alternative coating system is desirable or if repair to the existing coating system is a cost-effective option.

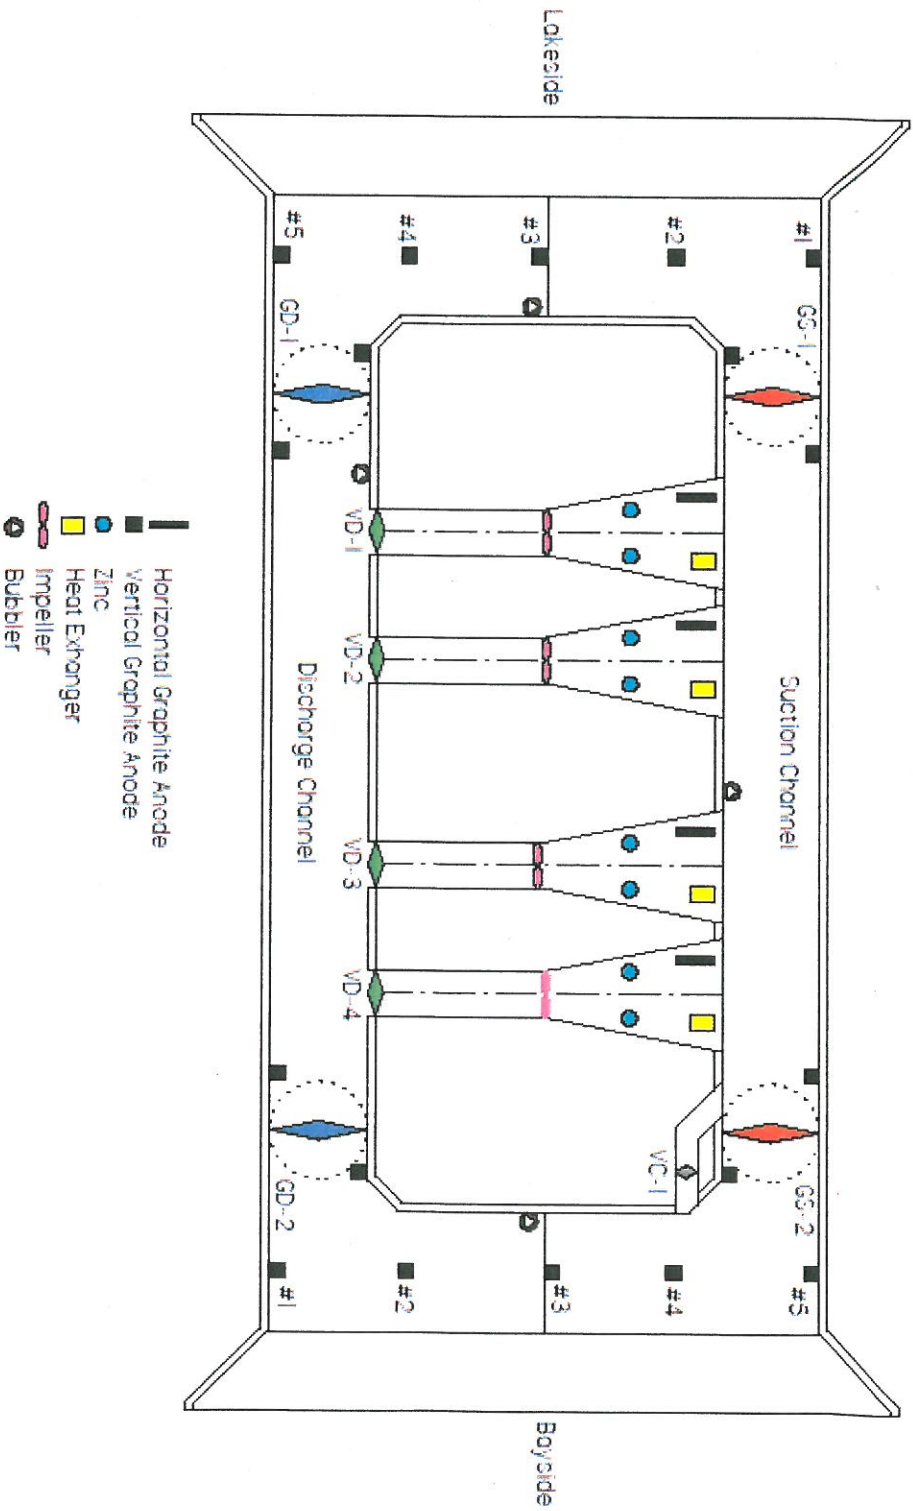
Some anodes were unable to be observed inside their PVC housings. Unexamined Horizontal Graphite Anodes (refer to attached diagram for locations):

- a. Lakeside #3 (at the divider screen)
- b. Gate GS-2 inside the suction channel
- c. Gate GD-2 inside the discharge channel
- d. Bayside #3 (at the divider screen)

5. Add larger ports or windows onto the PVC housings of the Horizontal Graphite Anodes noted as being un-inspectable underwater due to small ports in the housings.
