Appendix A
Notice of Preparation

Notice of Preparation of an Environmental Impact Report

Re: **Notice of Preparation (NOP) of an Environmental Impact Report (EIR) for the Cherryland Community Center Project**

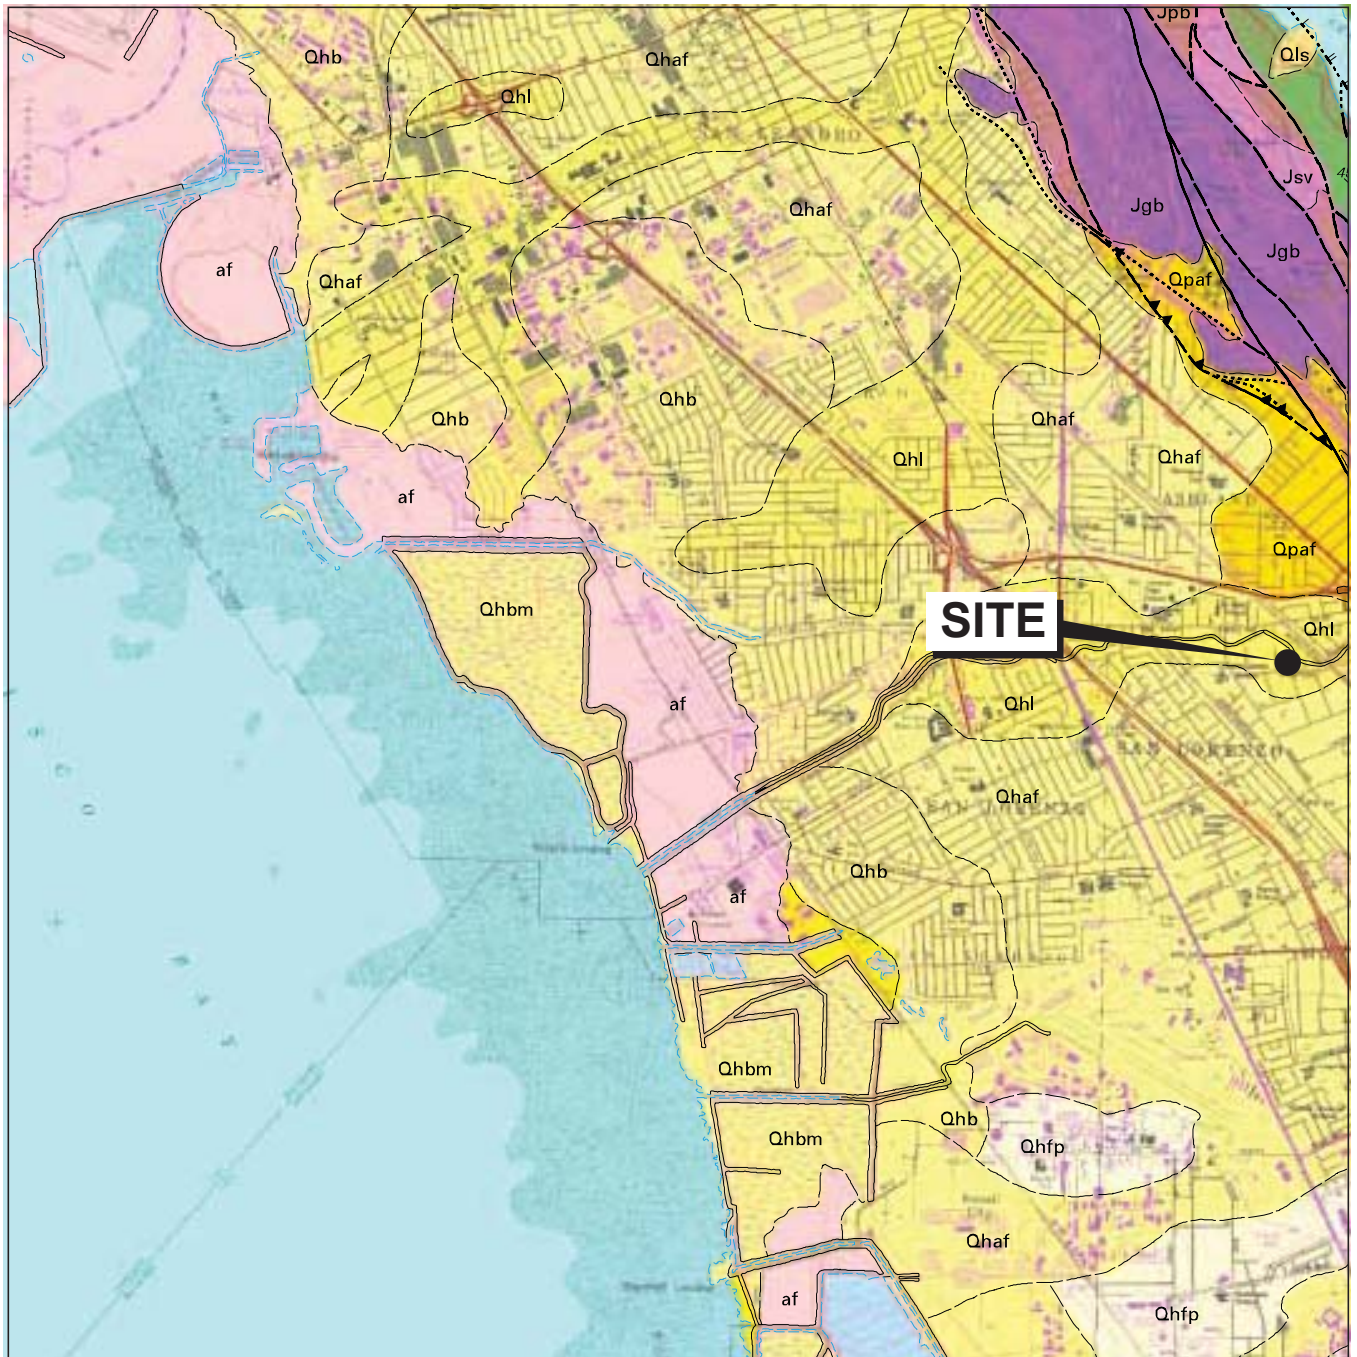
Date 12/15/13	Project No. 13-590	Figure 3
---------------	--------------------	----------

Base map: Geologic Map and Map Database of the Oakland Metropolitan Area, Alameda, Contra Costa, and San Francisco Counties, California, Graymer, 2000.

- af** Artificial fill (Historic)
- Qhaf** Alluvial fan and fluvial deposits (Holocene)
- Qhl** Natural levee deposits (Holocene)

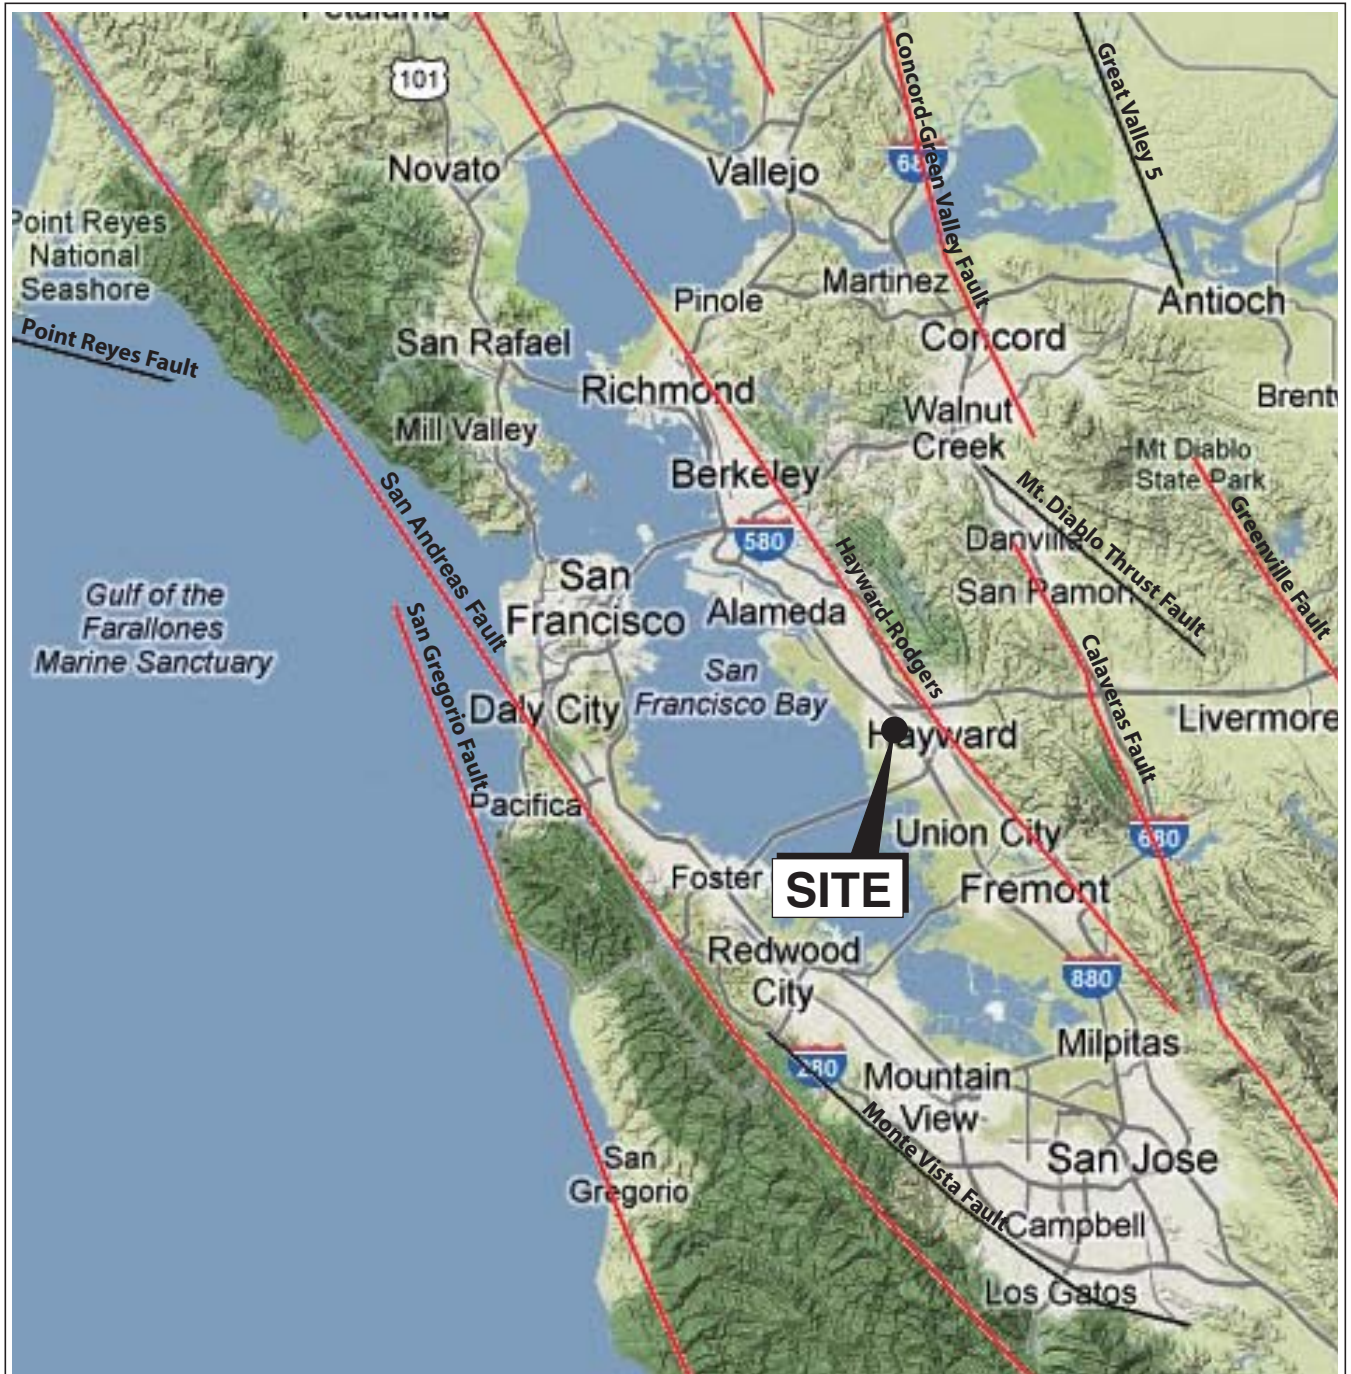
Base Map: U.S. Geological Survey, National Seismic Hazards Maps - Fault Sources, 2008.

The major active faults in the area are the Hayward, San Andreas, Calaveras, and San Gregorio faults. These and other faults in the region are shown on Figure 4. For these and other active faults within a 50-kilometer radius of the site, the distance from the site and estimated mean characteristic Moment magnitude¹ [2007 Working Group on California Earthquake Probabilities (WGCEP) (USGS 2008) and Cao et al. (2003)] are summarized in Table 1.

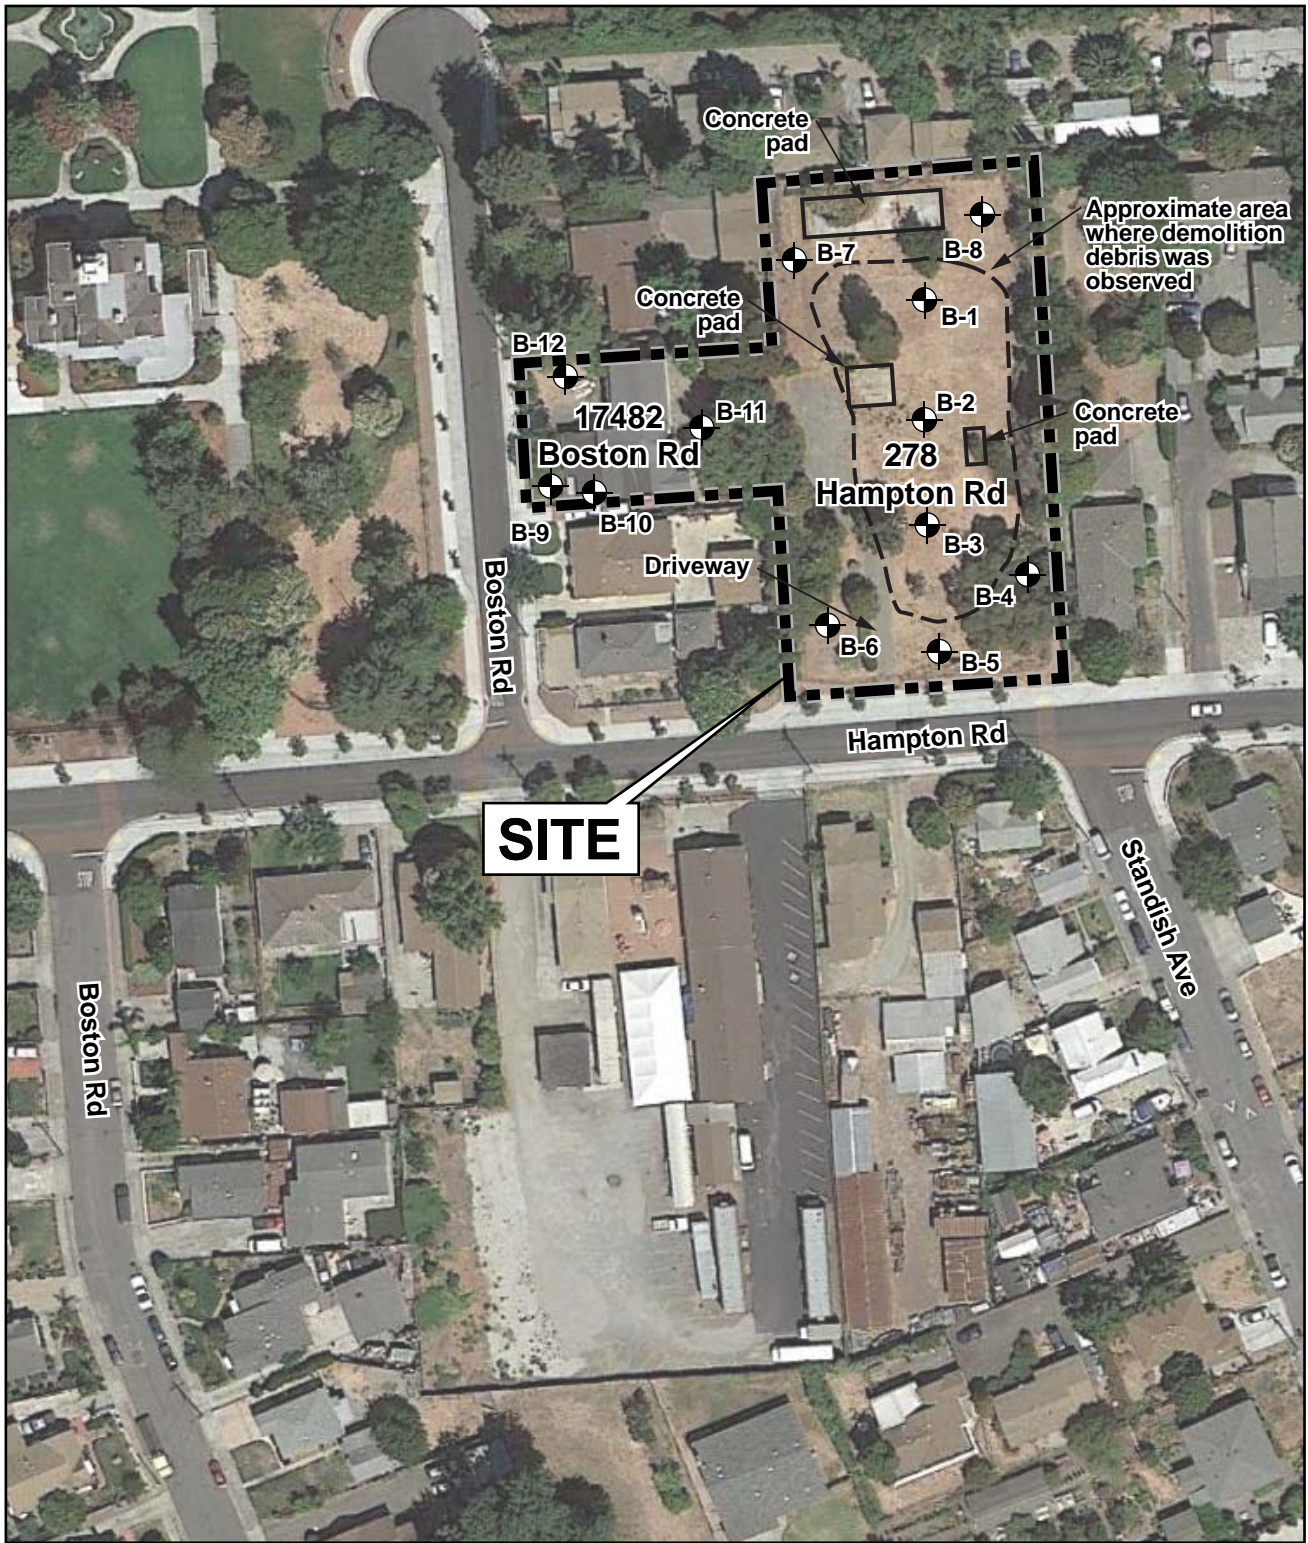
Figure
2

**SITE PLAN AND
DISCRETE BORING LOCATION MAP**
17482 Boston Rd and 278 Hampton Rd
Hayward, California

A total of (24) discrete soil samples from (12) soil borings (Figure 2) and (14) 3-point composite soil samples (Figure 3) were collected at the Site on October 10 and 16, 2013. A summary of sample collection performed at the Site is as follows:

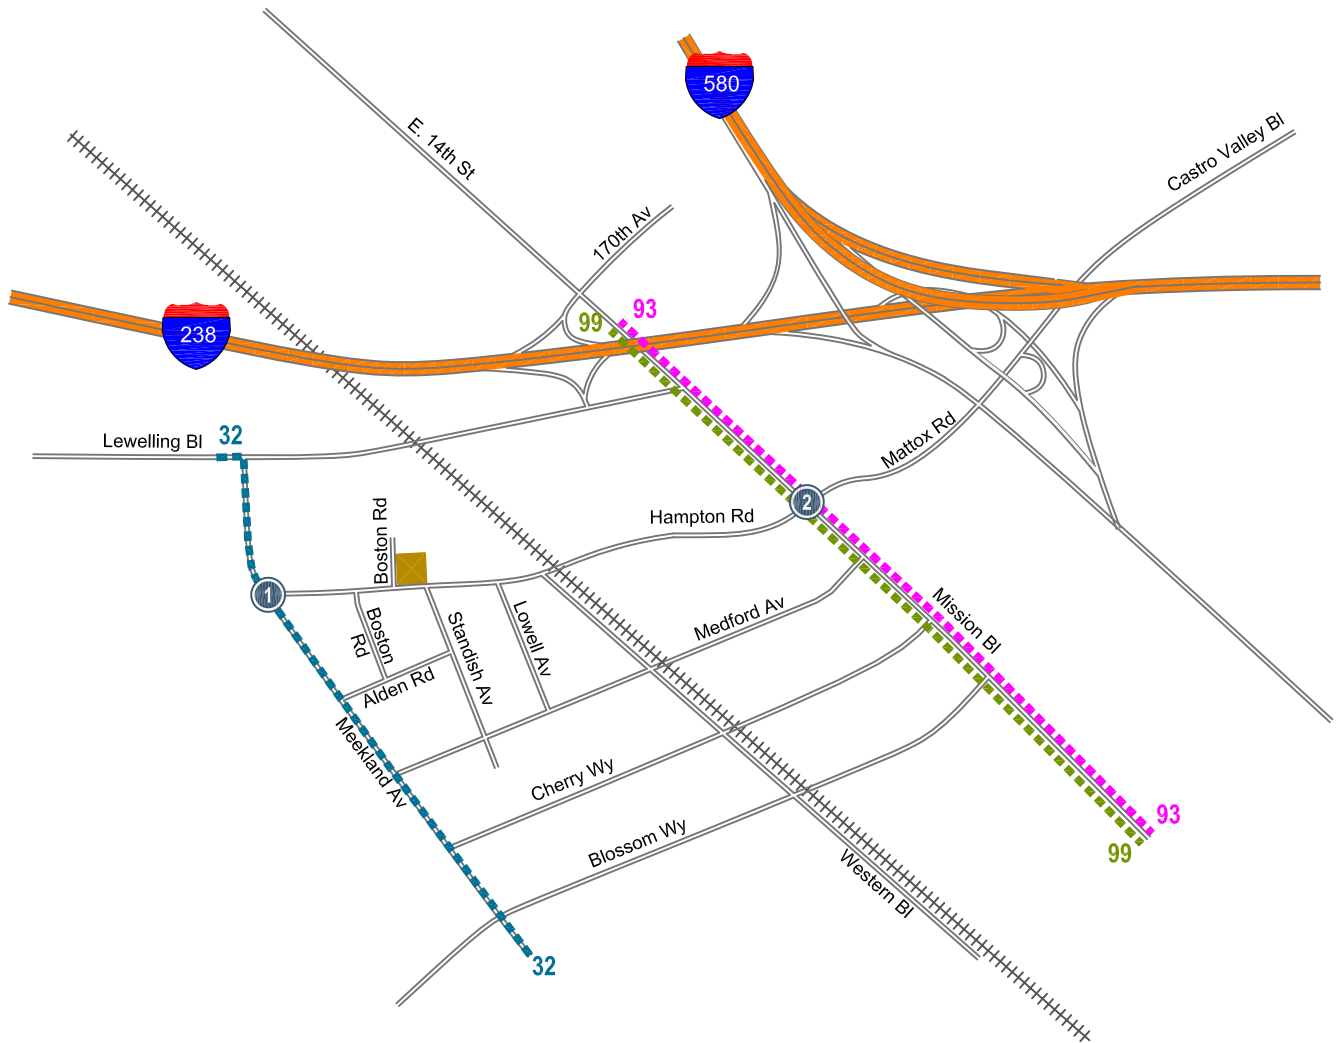
Figure 3
Existing Transit Service

Existing transit service to the study area is provided by Alameda-Contra Costa Transit District (ACTransit). The project is served by local bus lines 32, 93 and 99. The line 32 bus stops on Meekland Avenue near the intersection of Hampton Road. Line 32 provides service between BART Bayfair station and downtown Hayward and has 60-minute headways on weekends. On Mission Boulevard, ACTransit operates lines 93 and 99. Line 93 with headways of 60 minutes on weekends, provides service between the BART Bayfair station and Meekland Avenue. Line 99 provides service between BART Bayfair station and BART Fremont station, and operates with 30 minute weekend headways.

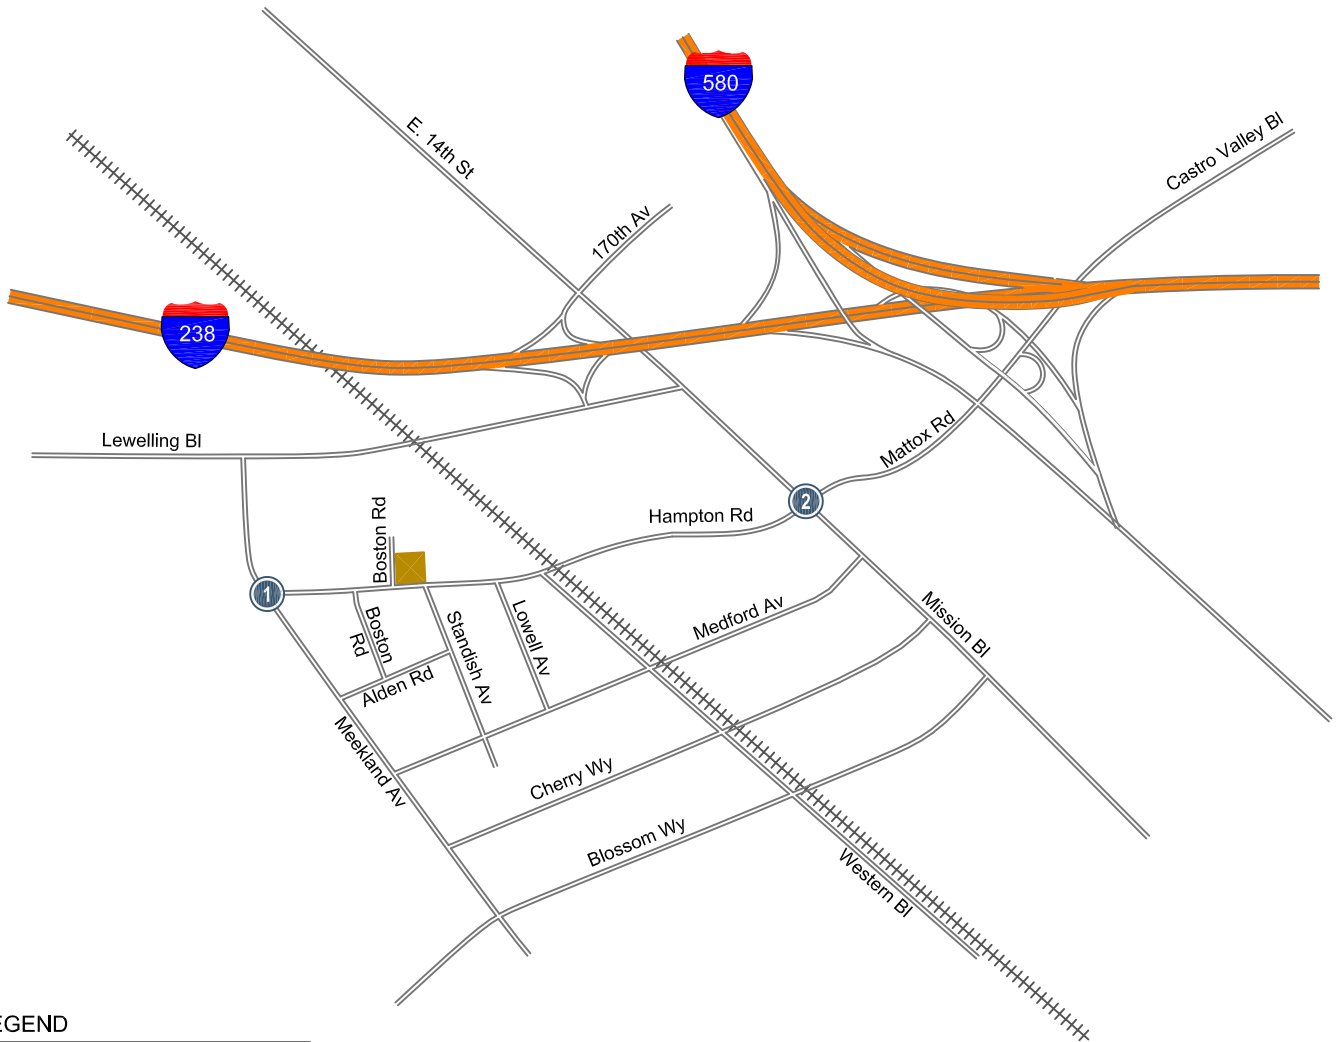
<p>1</p> <p>342(351) ↓</p> <p>122(134) ↔</p> <p>281(173) ↖</p> <p>86(53) ↖</p> <p>Hampton Rd</p> <p>Meekland Av</p> <p>344(458) ↑</p> <p>38(50) ↗</p>	<p>2</p> <p>75(45) ↖</p> <p>646(725) ↓</p> <p>90(141) ↖</p> <p>282(259) ↖</p> <p>205(163) ↑</p> <p>591(306) ↖</p> <p>Hampton Rd</p> <p>Hampton Rd</p> <p>57(47) ↗</p> <p>126(137) ↗</p> <p>17(25) ↗</p> <p>Mission Blvd</p> <p>6(24) ↔</p> <p>262(539) ↔</p> <p>213(375) ↔</p>
