# CROW CANYON ROAD SAFETY REPORT

**Greenridge Road to the Alameda/Contra Costa County Line  
MP 0.95 to MP 6.85**

MAY 2016

PREPARED FOR:  
ALAMEDA COUNTY PUBLIC WORKS AGENCY  
399 ELMHURST STREET  
HAYWARD, CALIFORNIA

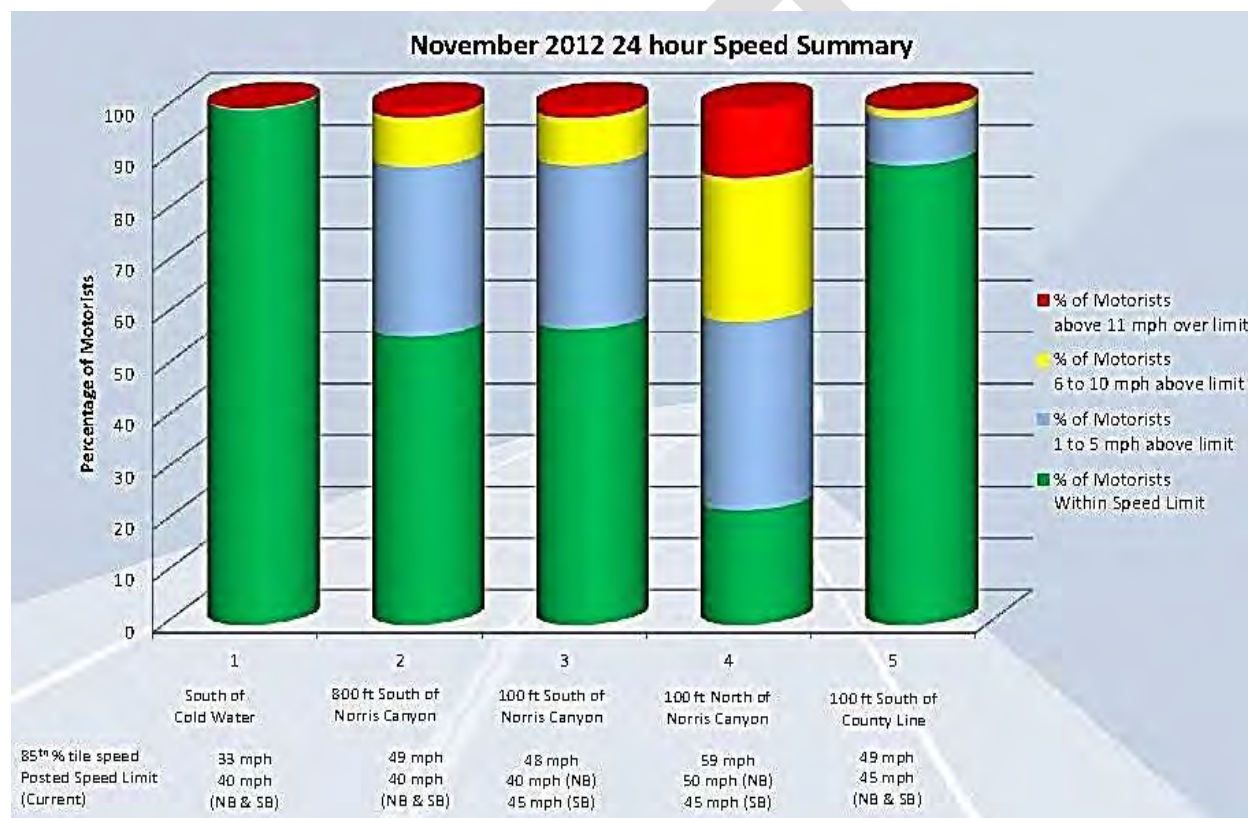
Vehicle speeds were determined through the use of road tube vehicle counters at strategic locations, as well as a series of travel time runs within the study limits. Results of the speed surveys are shown below.

The majority of vehicles within the study limits were travelling no more than 5 miles per hour in excess of the posted speed limit. The one exception is Segment 4, where nearly 50% of the vehicles were travelling at 6 or more miles per hour above the posted limit, with approximately 20% travelling 11 miles per hour or more above the limit.

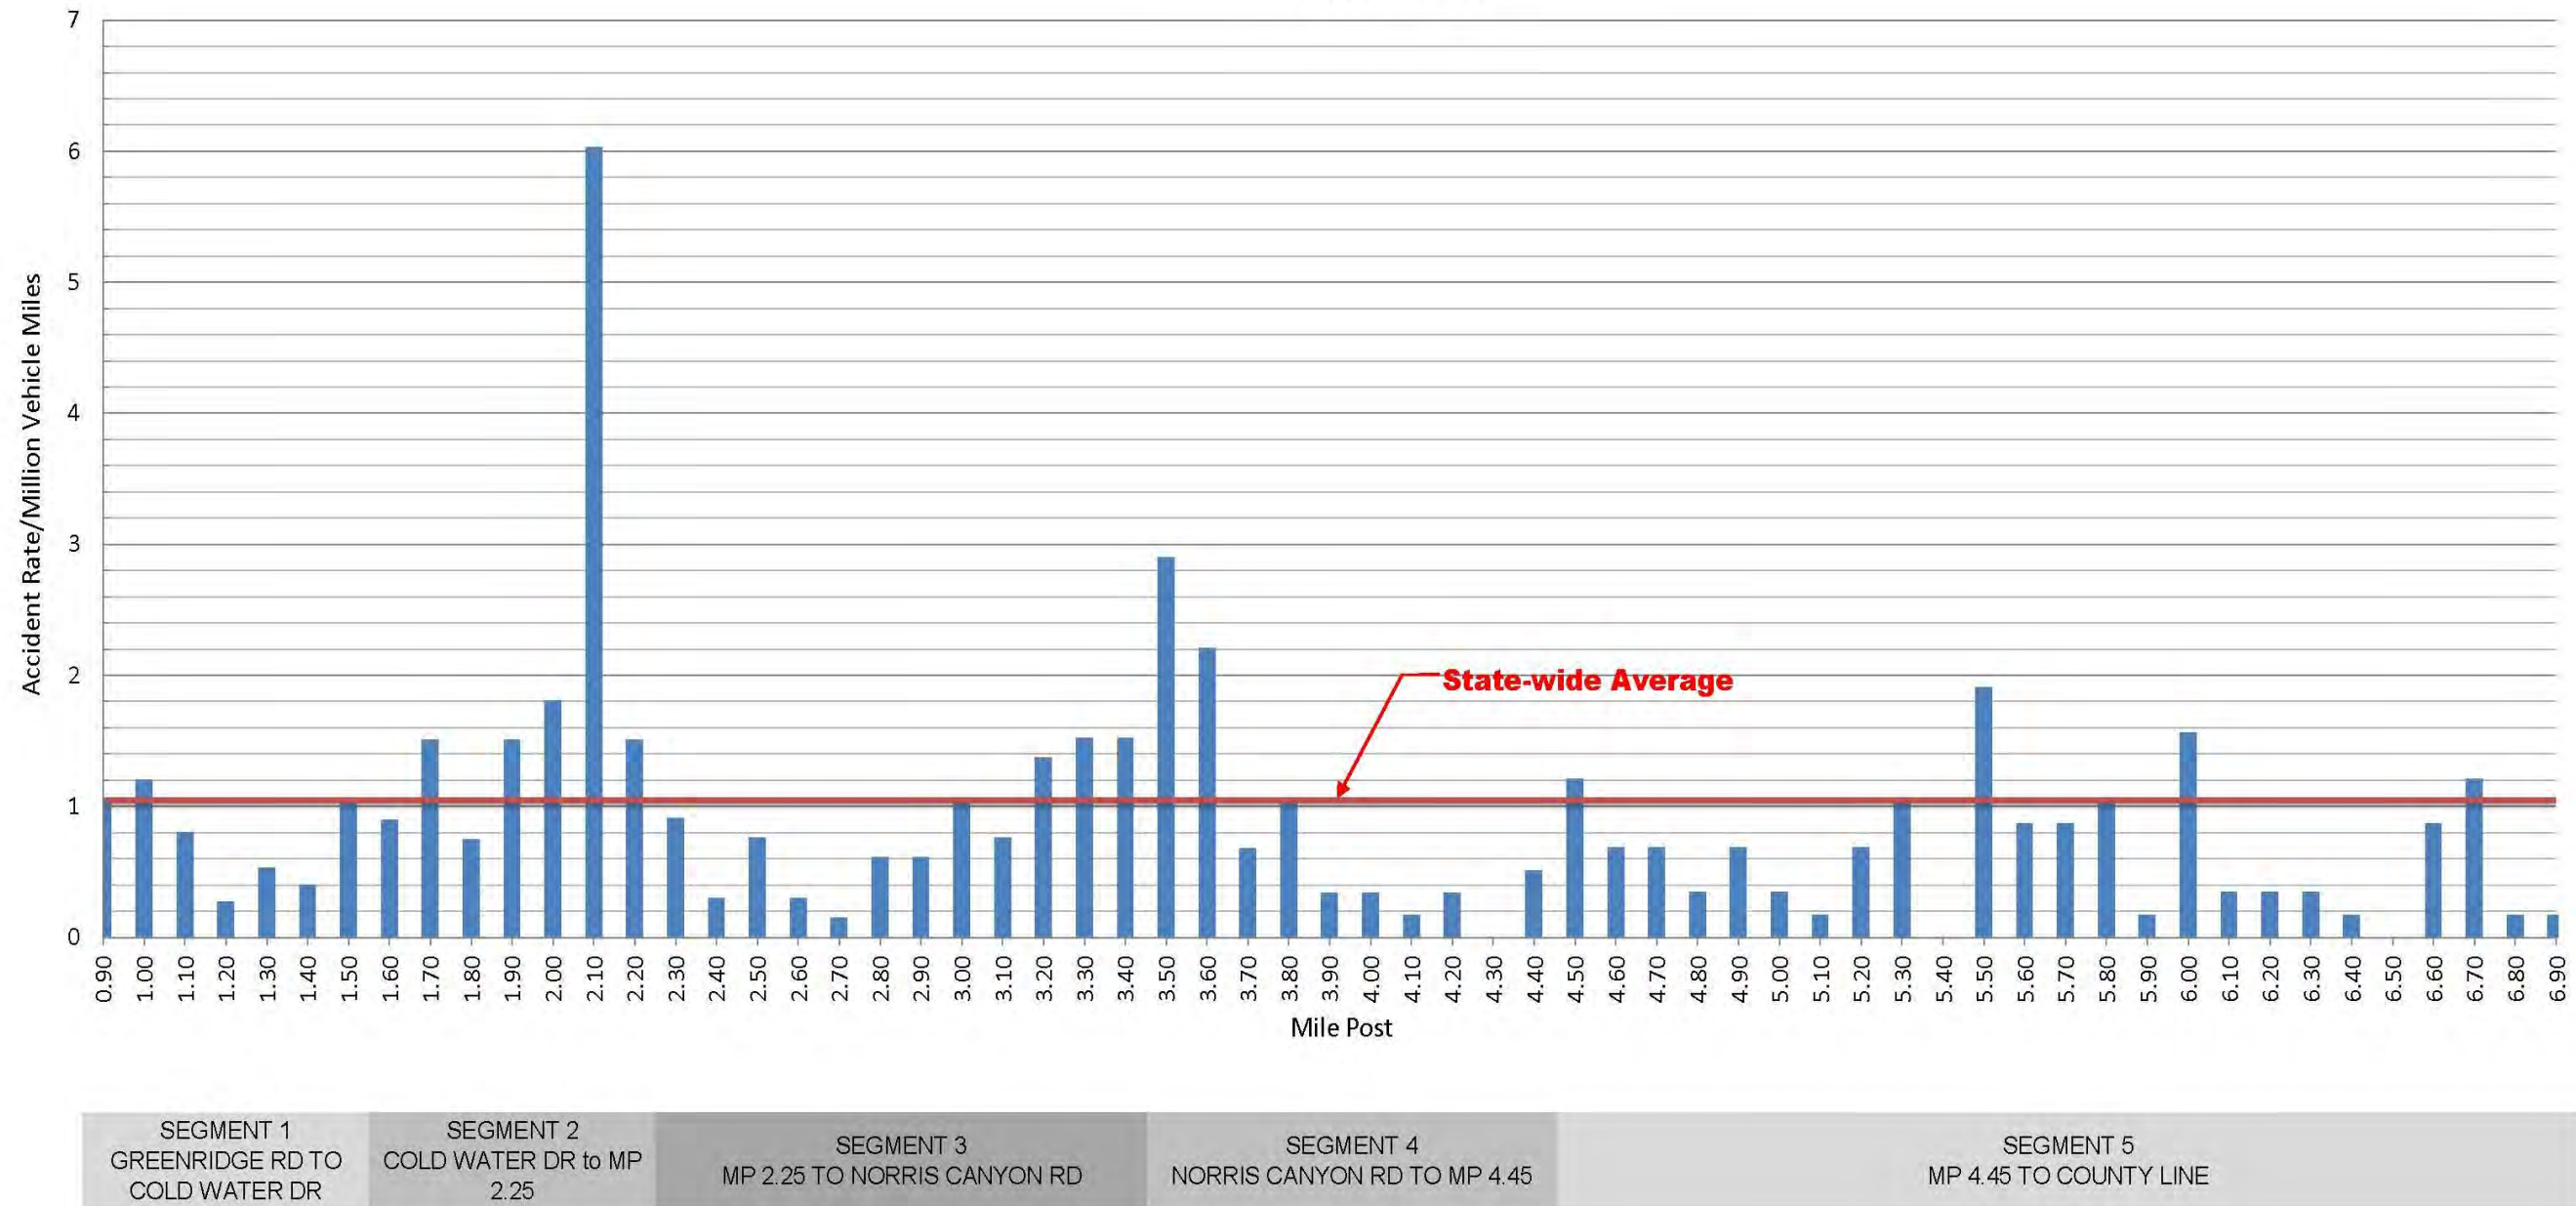
Accident Rate by Location

### ACCIDENT RATE BY LOCATION 2003 - 2013

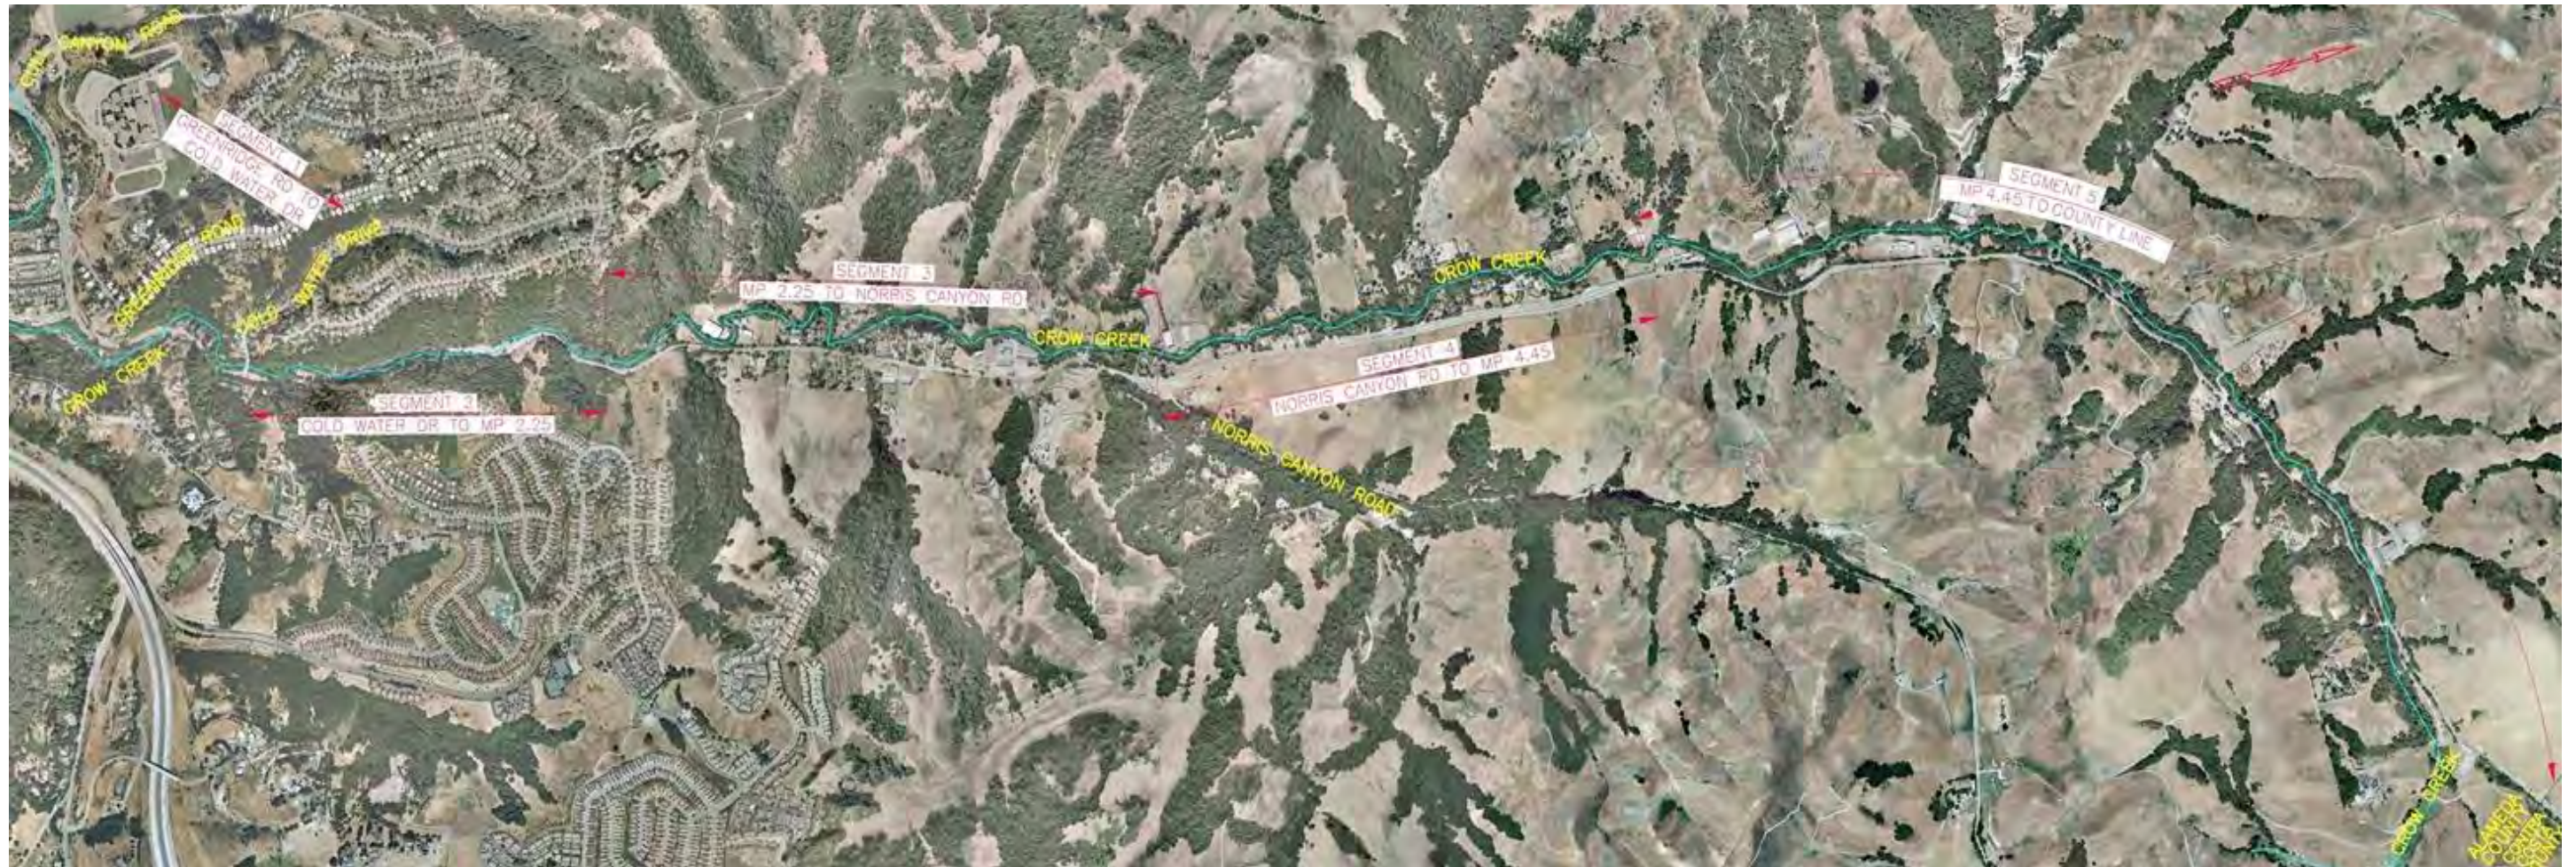
Figure 2. Project Limits

- Segment 5: Mile Post 4.45 to Alameda/Contra Costa County Line—The alignment of this 2-lane segment consists of numerous horizontal and vertical curves for a distance of approximately 2.4 miles. The posted speed limit is 45 mph. The area immediately adjacent to the roadway is partially developed with driveway access to rural residential and commercial uses. The remainder is rolling grasslands or heavily wooded.

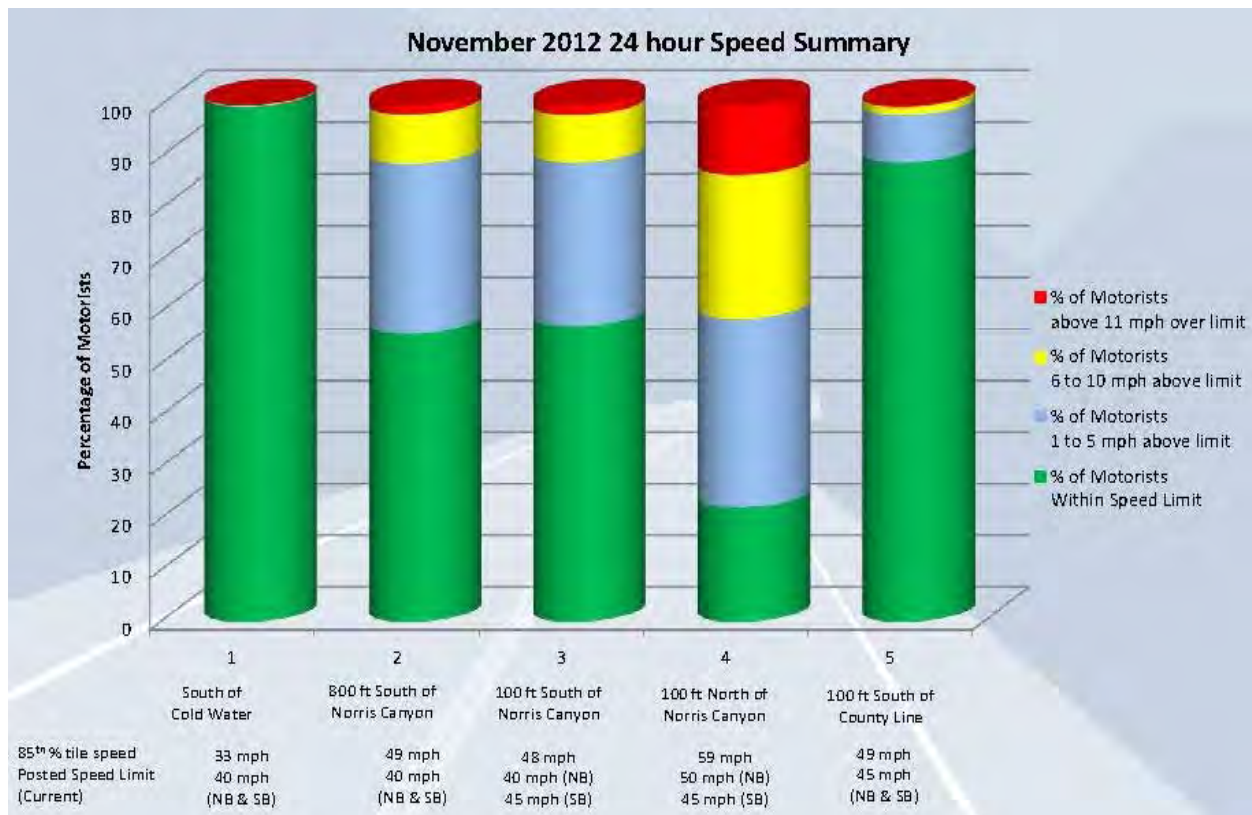
**Figure 3. Vehicle Spot Speeds**

The use of road tube vehicle counters at strategic locations, as well as a series of travel time runs within the study limits were used to estimate existing vehicle speeds within each of the 5 segments. Locations of the road tube vehicle counters on Crow Canyon Road, as well as speed profiles and recorded 85<sup>th</sup> %-tile speeds for the 5 study segments are shown in Figure 3.

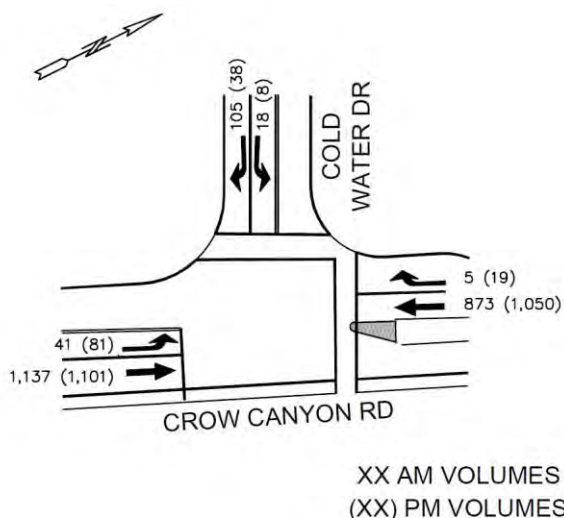
**Figure 4. Existing Peak Hour Volumes for Crow Canyon Rd./Cold Water Dr. Intersection**

Existing peak hour turning movement counts were collected at the two road intersections within the study limits—Crow Canyon Road and Cold Water Drive and Crow Canyon Road and Norris Canyon Road. The morning peak hours for the Cold Water Drive and Norris Canyon Road intersections were 7:20 a.m. to 8:20 a.m. and 7:15 a.m. to 8:15 a.m., respectively. The corresponding afternoon peak hours were 4:40 p.m. to 5:40 p.m. and 4:50 p.m. to 5:50 p.m. Figures 4 and 5 indicate the observed intersection volumes.

Level of Service (LOS) calculations show that the two intersections are currently operating within acceptable conditions. At the Cold Water Drive intersection, the morning peak hour average delay is 11.1 seconds, or LOS B. During the afternoon peak hour, this intersection operates at LOS A with 6.0 seconds of delay. Similarly, at the Norris Canyon Road intersection, both morning and afternoon peak periods operate at LOS A with 5.8 seconds and 8.0 seconds of delay, respectively.

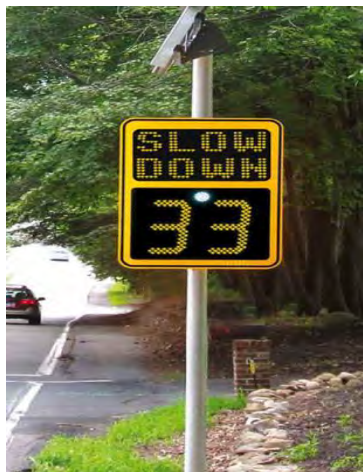
A vehicle speed feedback sign displays to approaching drivers the speed at which they are traveling. The purpose of the sign is to slow vehicles down by alerting drivers they are travelling at an unsafe speed.

The signs are typically installed as an alternative to physical devices (speed bumps, speed tables, etc.), where traffic volume and vehicle speeds would make the installation of physical devices unsafe. The sign is an interactive sign, generally constructed of a series of LEDs. These signs are typically installed in conjunction with an R-2 Speed Limit Sign. Numerous studies have shown that the signs are effective at reducing the average speed of vehicles.

This countermeasure consists of installing nine speed feedback signs at locations along the entire corridor where speed surveys indicated a large percentage of drivers exceeding the speed limit and at locations in advance of horizontal curves with limited sight distance. These locations are shown in Figure 21. These installations would be solar powered and have minimal impact to the roadside environment.

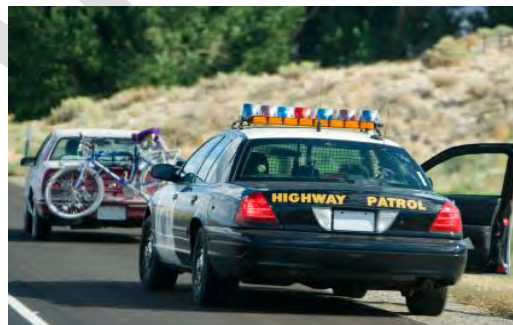
Police enforcement areas provide widened paved shoulder areas at strategic spacing where an officer can sit and observe motorists and a place where the officer can have a targeted vehicle pull over for enforcement of traffic (particularly speeding) infractions. This safety element has the potential of reducing accidents resulting from speeding (by the presence of a police officer) and by moving parked vehicles further from the edge of the traveled way.

This countermeasure consists of paving 20 areas adjacent to the existing roadway, in most locations providing pervious pavement over the existing graded shoulder area. The paved areas would be 8 feet in width and of a sufficient length to allow vehicles to decelerate safely off, and accelerate safely into the traveled way. The pavement edge should be constructed at a 30 degree angle to provide a "Safety Edge" as described in Countermeasure 4. The exact location of the paved areas could be sited to avoid the removal of any trees and to impart minimal impact to the roadside environment. The proposed enforcement areas are shown in Figure 21.

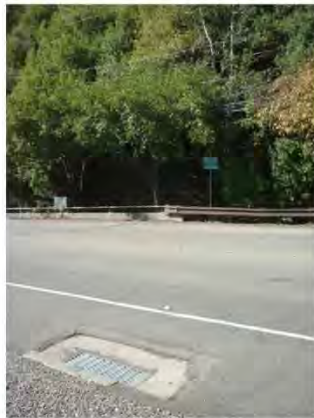
Photo 1. Curb and Inlet (PM 1.30, Rt)

The existing drainage system within the Project limits consists of curbs, dikes, and ditches that convey runoff to inlets, cross culverts, and downdrains that eventually outfall into Crow Creek. At locations where a median ditch is present, the roadway runoff drains toward the median ditch, which conveys runoff to inlets and into culverts that discharge to Crow Creek.

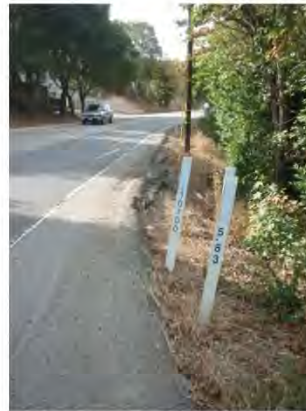
Photo 2. Sheet Flow to Roadside Ditch (PM 5.83, Lt)

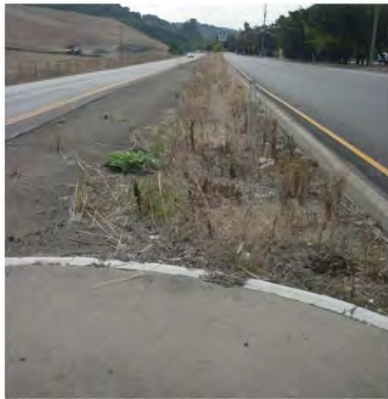
Photo 3. Ditch at Median (PM 3.85)

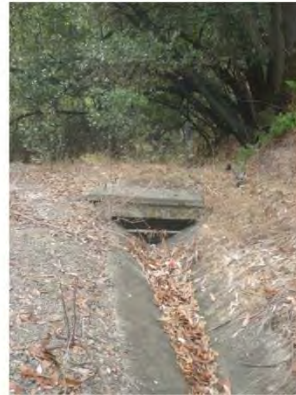
Photo 4. Lined Ditch to Drop Inlet (PM 1.66, Lt)

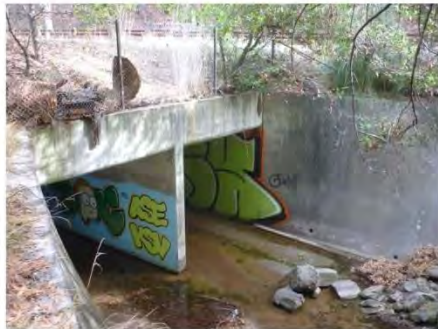
Photo 5. Box Culvert for Crow Creek (PM 1.66, Lt)

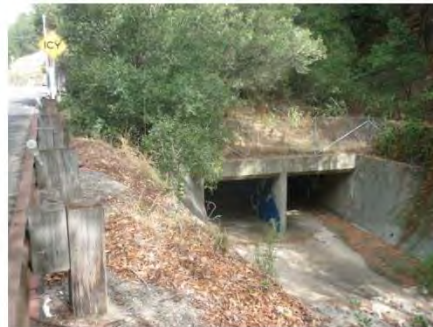
Photo 6. Box Culvert for Crow Creek (PM 1.96, Rt)

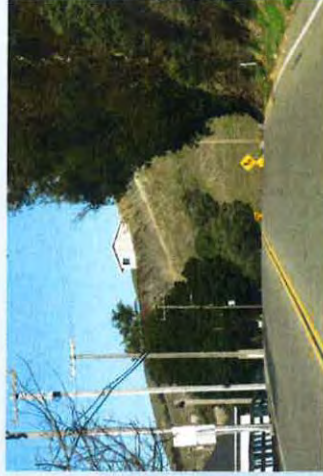
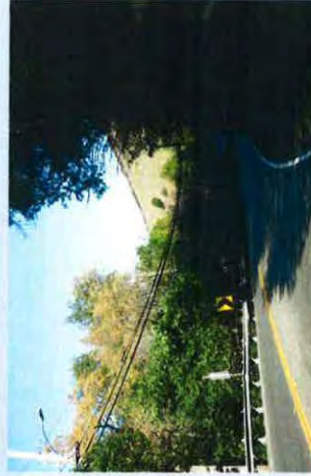
- Varying roadway alignment
  - Tight curves
  - Blind spots
  - Varying speed zones
  - Multiple driveways

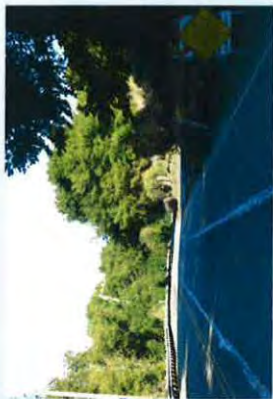
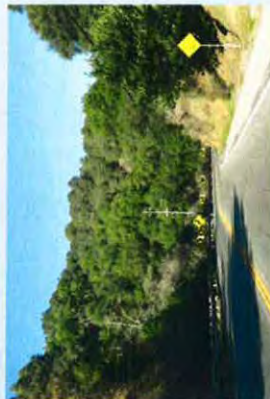
- Limited shoulder width
  - Narrow or unpaved
  - Minimal space outside of traveled way for bicycles / pedestrians / equestrians
  - Minimal space beyond traveled way for maintenance crews
  - Minimal refuge areas for vehicle break-downs
- Constrained roadside conditions
  - Steep side slopes and/or ditches
  - Slide/erosion areas
  - Crow Creek running alongside and underneath roadway

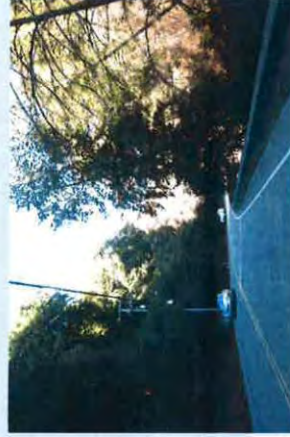
- Limited off-road recovery space
  - Above ground utilities
    - Poles, hydrants and drainage structures
  - Rock formations
  - Lined and unlined ditches
  - Guard rail and bridge railings
  - Retaining walls / fences
  - Steep slopes

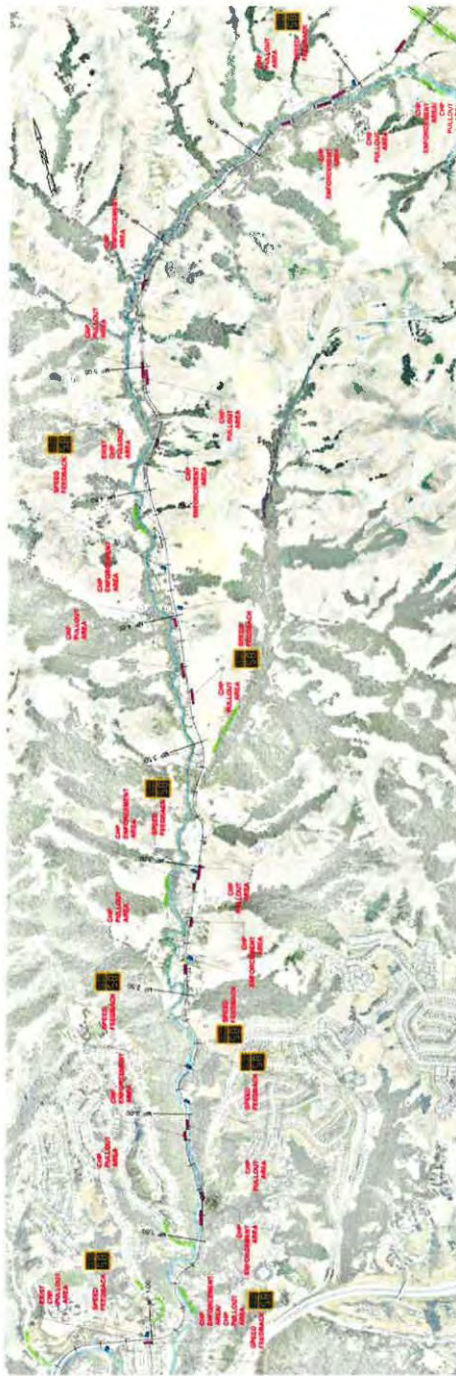
CROW CANYON ROAD SAFETY STUDY  
POTENTIAL CORRIDOR SPEED REDUCTION COUNTERMEASURES  
SHORT TERM - ENHANCED SPEED ENFORCEMENT
