TESLA ROAD SAFETY STUDY

REPORT

Public Works Agency
— Alameda County —

May 2015

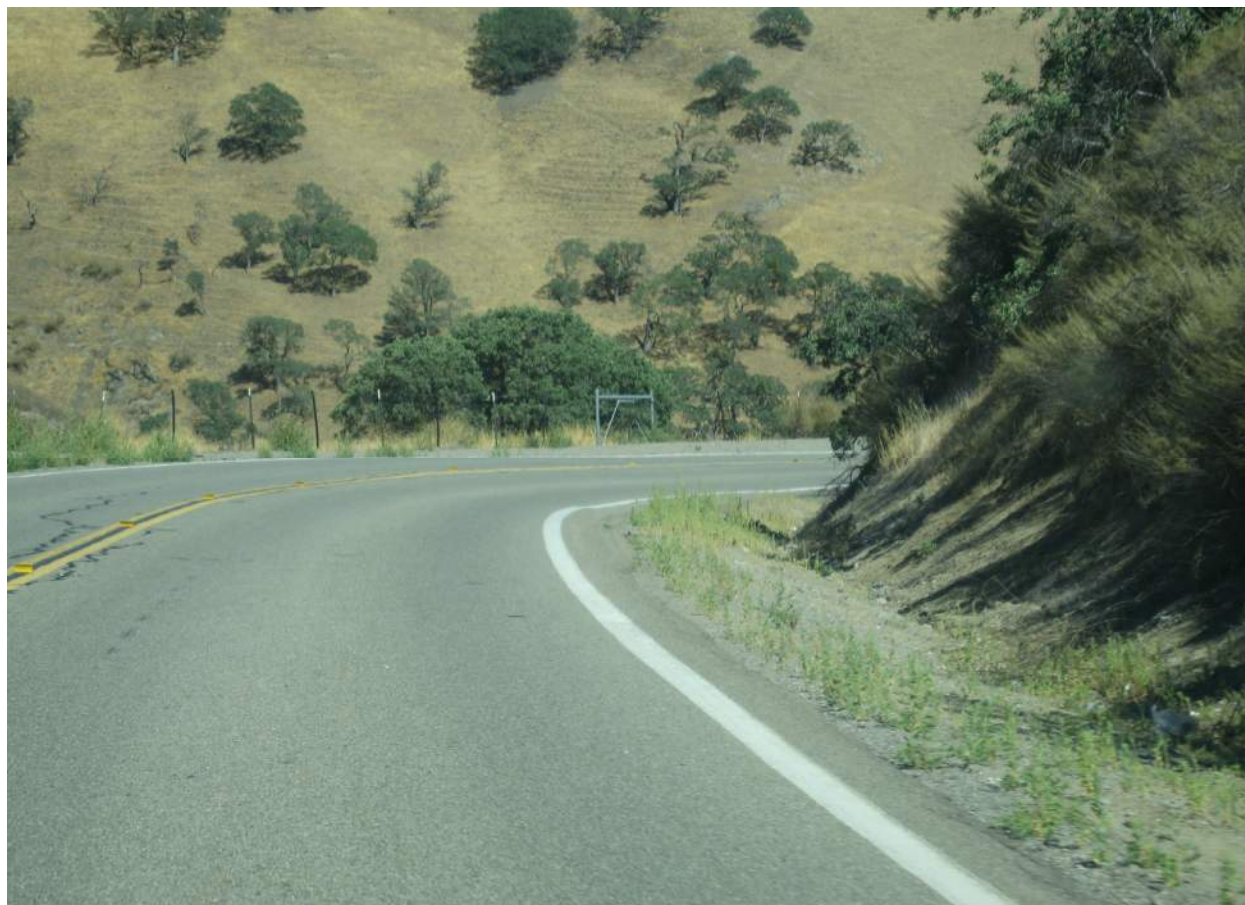
Figure 2 Typical horizontal curve with limited sight distance on Tesla Road

Portions of Tesla Road have horizontal and vertical curves with limited sight distance. There are also reverse curves, also known as S-curves, along the roadway that do not meet current design standards and have limited sight distance. At some locations there are warning signs that do not meet current sign standards. There are also a limited number of warning signs to warn the drivers of the impending sharp curves. Drivers who enter the horizontal curves above the posted speed limit may not observe the signs warning the sharpness of the curve, and fail to negotiate the curve safely. Figure 2 is a typical example of a curve along Tesla Road with limited sight distance.

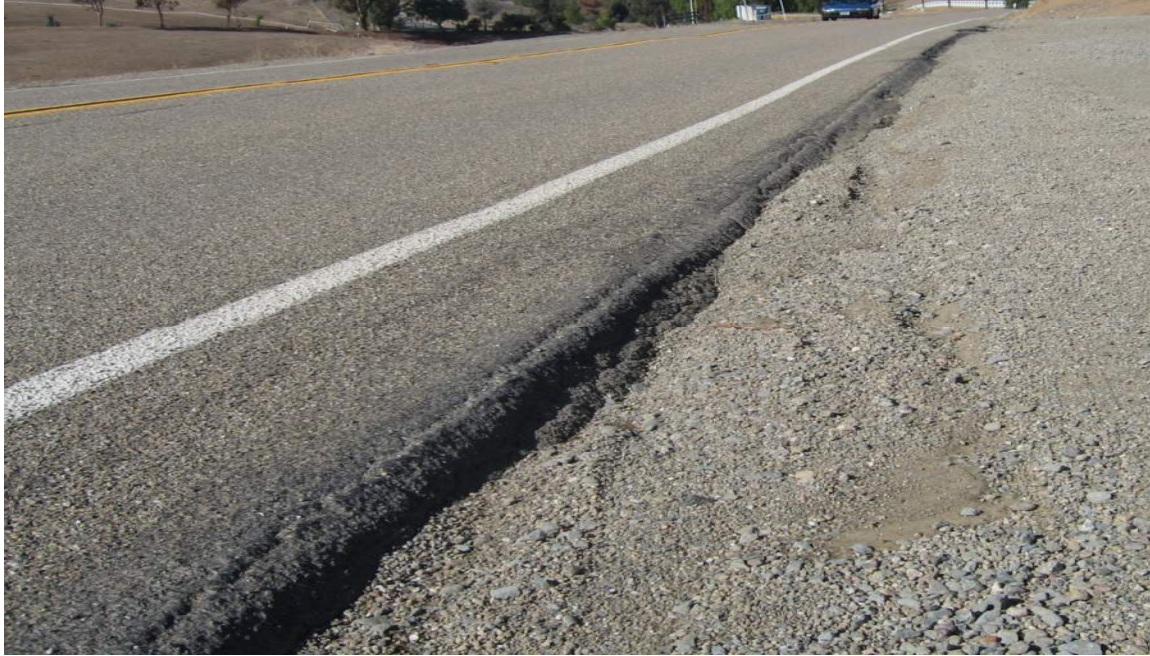
Figure 3 Shoulder drop-off with loose gravel

There are several locations along the corridor where there are shoulder drop-offs. Shoulder drop-off is a situation where there is an elevation difference between the edge of pavement or edge of traveled way and the unpaved shoulder. An example of a shoulder drop-off on Tesla Road is shown in Figure 3. On Tesla Road, the drop-offs vary in height and exceed four inches at some locations. For most of the corridor, the narrow shoulders are bordered by dirt, loose gravel or loose rock that has been placed for drainage purposes. Shoulder drop-offs coupled with very soft shoulders or loose rock can result in the driver losing control of the vehicle once the vehicle is off the paved road and greatly reduce the chance of recovery.

for errant vehicles. In the near term it is recommended that edge drop-offs be eliminated by re-grading and compacting the unpaved shoulders as shown in Figure 17. It is also recommended that pavement edge drop-offs created by future resurfacing of the existing roadway or widening of shoulders be addressed by constructing a beveled 30 to 35 degree asphalt wedge, typically called as a safety edge, at the edge of the paved shoulder.

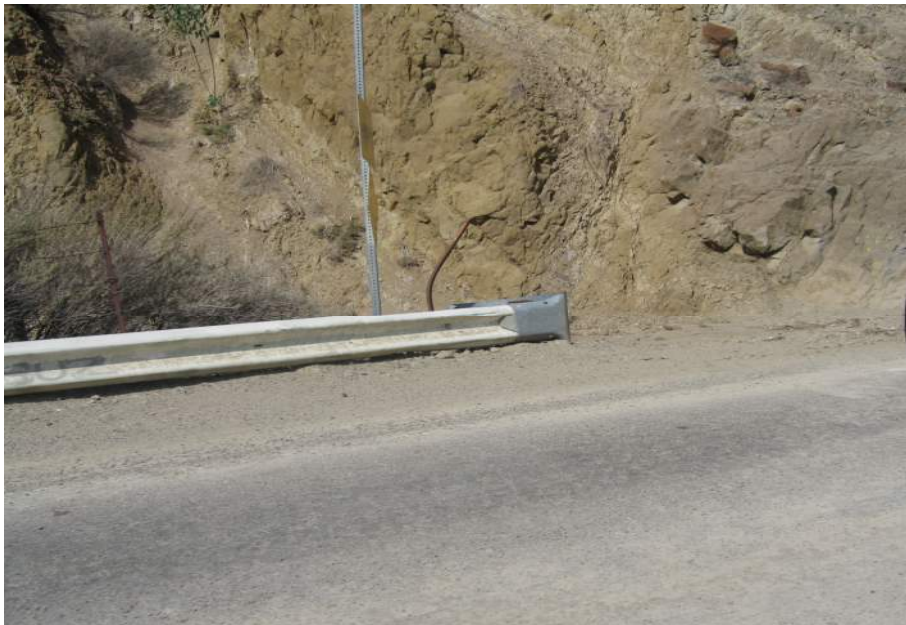
Figure 4 Guard rail with non-standard height

Guard Rails are recommended where the severity of damage to an errant vehicle striking the guard rail is less than the damage to a vehicle running off of the road. There are several locations along the Tesla Road corridor where the existing guard rails need to be replaced as they do not meet the current design standards for guard rails. Figure 4 shows a typical example of a location where guard rail needs to be replaced because of non-standard height.

Guard rail was installed at numerous locations along Tesla Road. At several location the existing guard rails do not meet the current standards for guard rails. Two existing guard rails were identified to be replaced in the near-term and are shown in Exhibit 6. Replacing these two guard rails does not require significant excavation, re-grading of the slopes, right of way acquisitions or slope easements. The replaced guard rails will conform to current Caltrans standards.

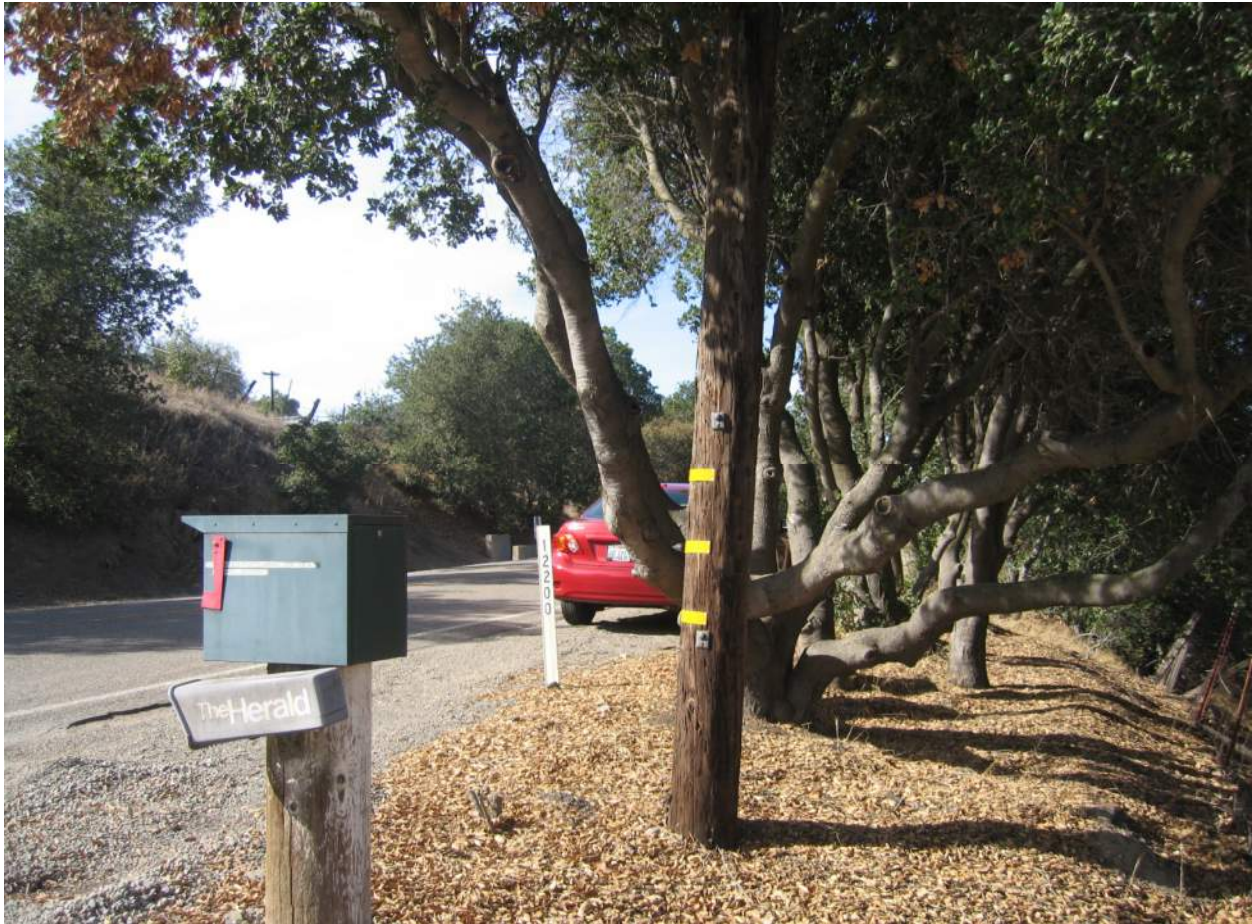
Figure 5 Example of driveway with reduced sight distance because of trees

Additionally, there are numerous trees along both sides of the roadway. At some locations, these trees reduce the sight distance of drivers exiting these driveways. The minimum required sight distance for Tesla Road, per the Caltrans Highway Design Manual and the Tesla Road Project Design Criteria, is 360 feet. Figure 5 shows a typical example of a driveway where trees obstruct the line of sight of the driver entering the roadway. There are several driveways along Tesla Road that are on a horizontal curve alignment. The sight distance at some of these locations is also limited due to cut slopes and trees adjacent to the roadway.

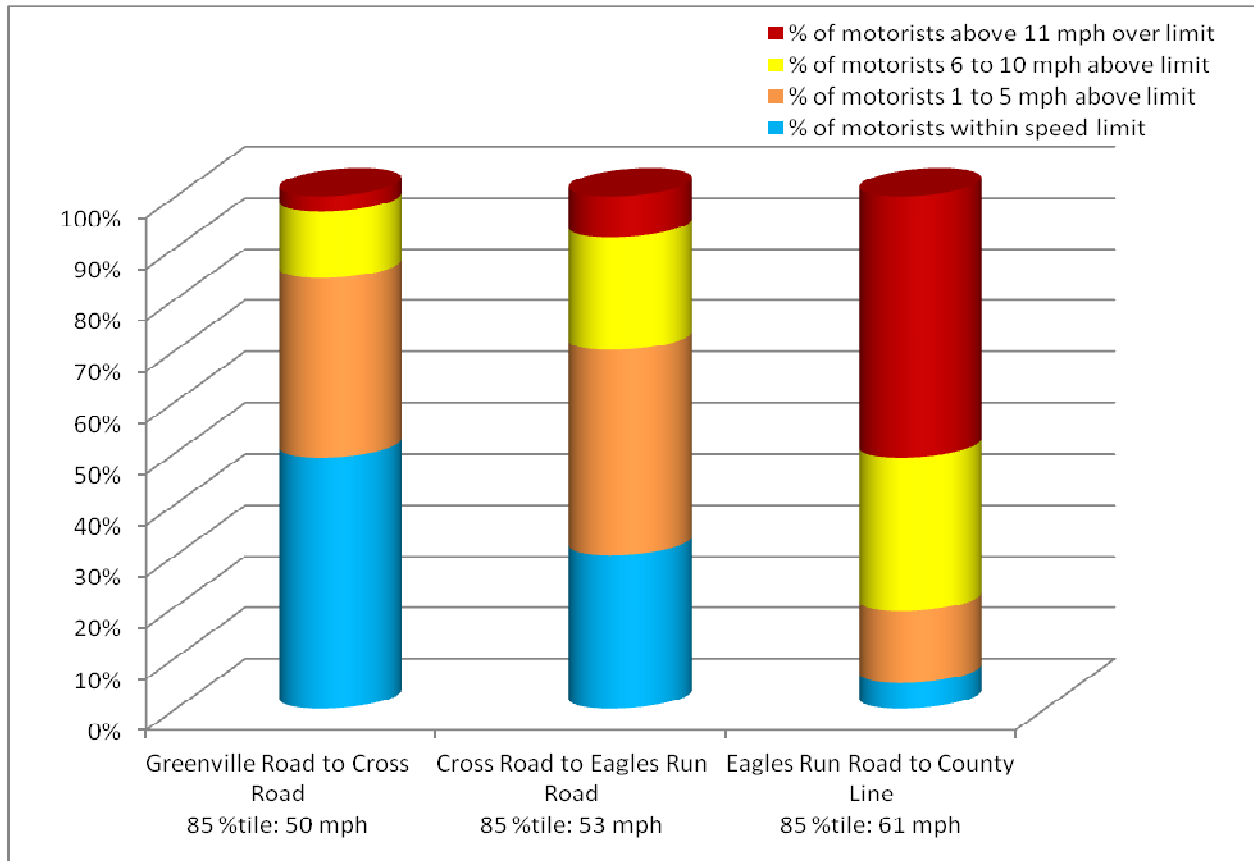
Figure 7 Speed Summary

Table 3 identifies the posted speed limit along Tesla Road with statistical speeds on all the segments of the roadway. Figure 7 provides further breakdown of speeds on the three segments showing that a great majority of motorists in segments 1 and 2 are traveling at speeds no more than 5 mph above the posted speed limit. However, in segment 3, only 40% of motorists are traveling at speeds no more than 10 mph above the speed limit.

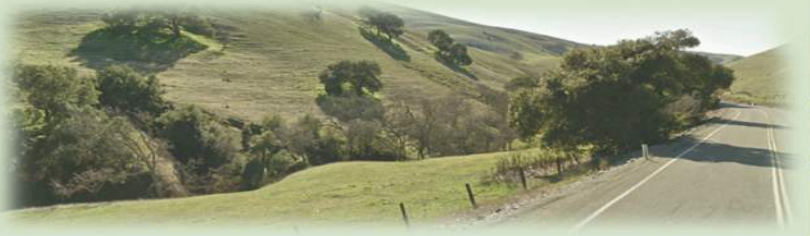
Incident Locations and Types 2009 to 2012

INCIDENT TYPE			
Single w/o Injury	Single with Injury	Multiple w/o Injury	Multiple with Injury
21	17	7	9
39%	31%	13%	17%
Total of 54 incidents

A total of 54 collisions occurred within the project study limits during the 2009 to 2012 analysis period. None of these collisions were fatal. Table 4 shows the collision data broken down by segments and type of the collisions. It can be seen from Table 4 that “Hit Object” constitutes about 50% of the collisions indicating that vehicles running off the road is the most common problem along the roadway. This underscores the need for an adequate clear zone for errant vehicles to recover and for clear markings and signs to reduce the number of vehicles straying off of the pavement. Figure 8 shows collisions plotted along the length of the corridor.

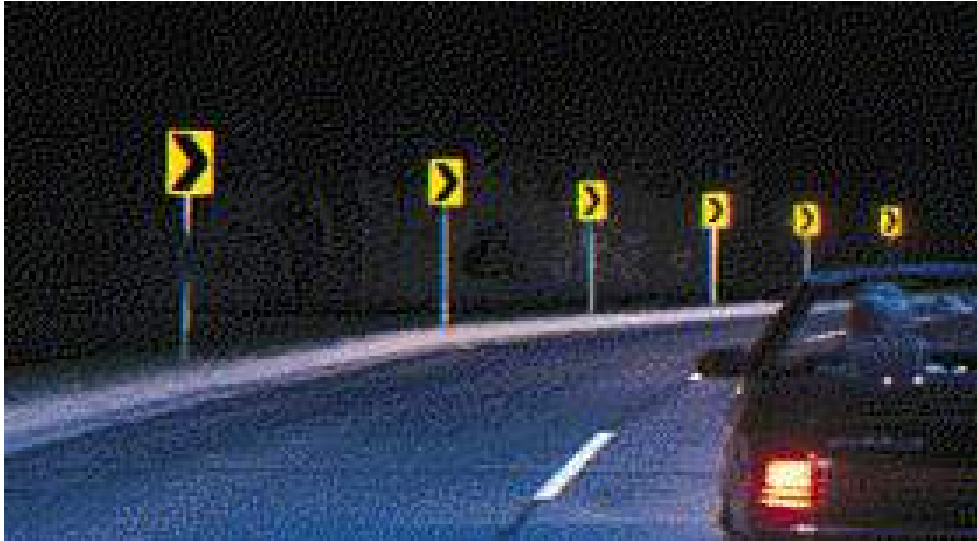
Figure 10 Chevrons along a sharp curve

Figure 10 shows an example of warning signs along the outside edge of a sharp curve. Warning signs similar to those shown on Figure 10 are recommended along certain horizontal curves on Tesla Road to help drivers safely negotiate these curves. Exhibit 1 shows both the existing signs and proposed new signs along the roadway corridor.

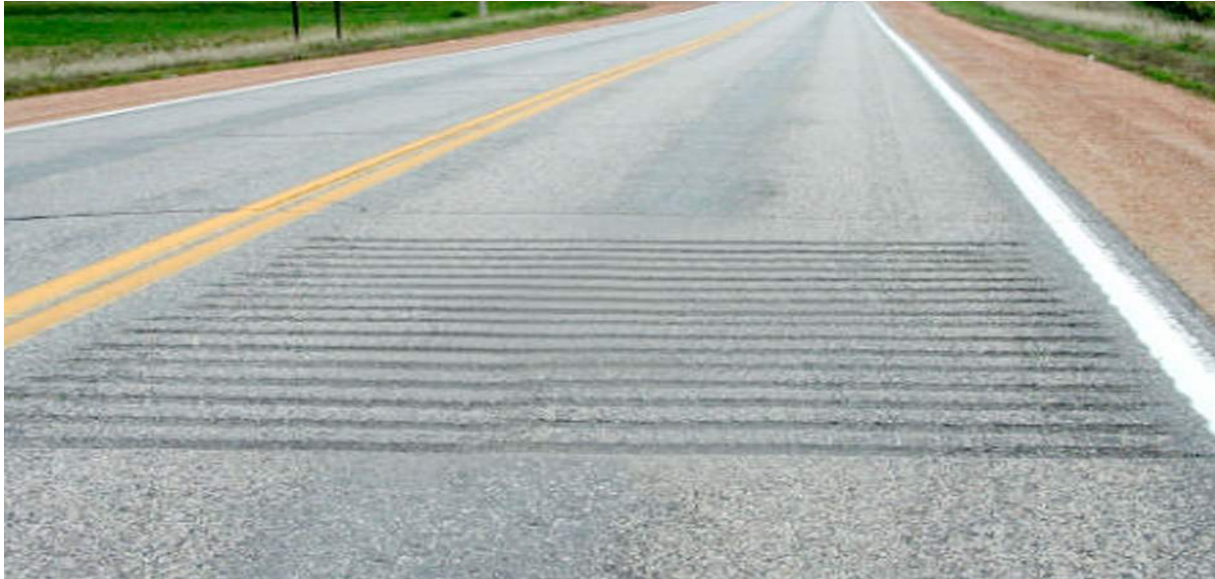
Figure 16 Transverse Rumble Strip

Installing transverse rumble strips on the approach of a sharp curve with reduced speeds will alert the drivers of the reduced speed warning signs and encourage them to reduce their speed and be cautious as they approach and negotiate the curve. It is recommended that transverse rumble strips be placed at two locations, which are shown on Exhibit 11.

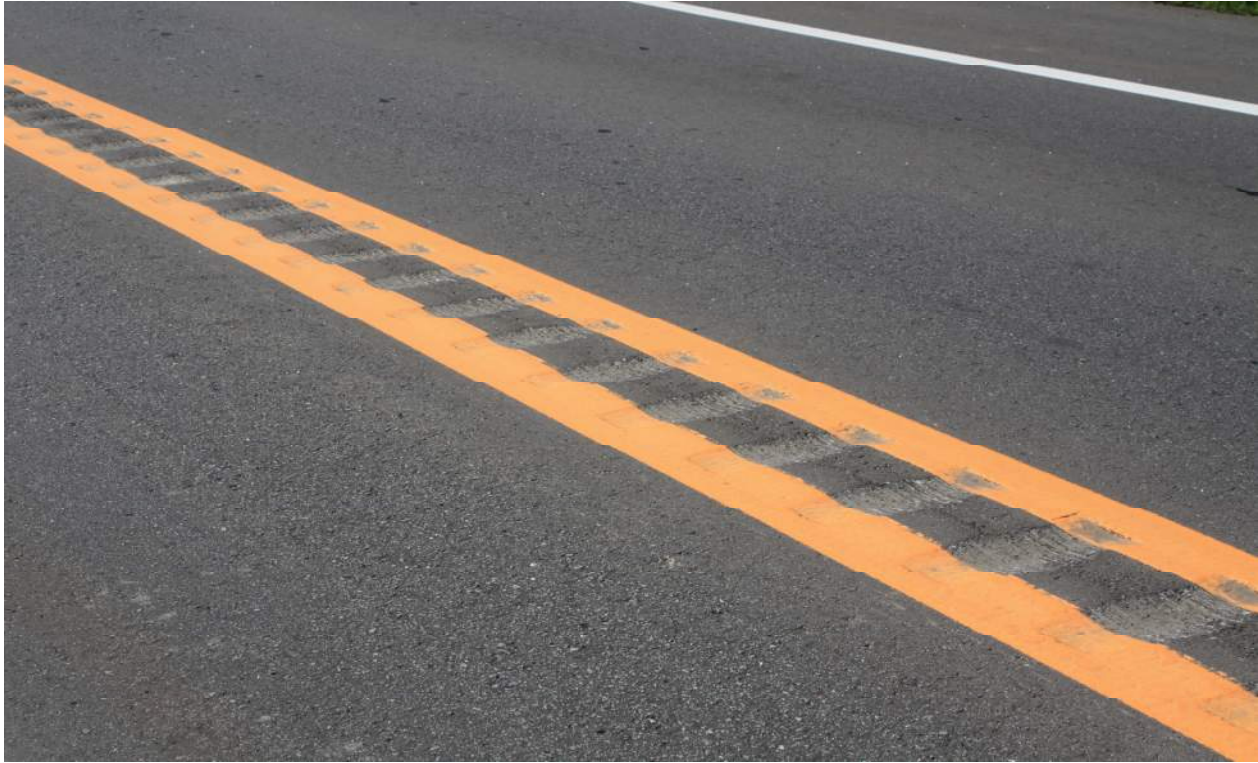
Figure 18 Typical Centerline Rumble Strip

This countermeasure would install centerline rumble strips throughout the corridor. However, due to the reduced lane widths along most of the corridor, it is recommended that centerline rumble strips be installed along with or after the four foot wide paved shoulders are installed. Exhibit 7 shows a schematic view and limits of the centerline rumble strips; Figure 18 shows an image of a typical centerline rumble strip.

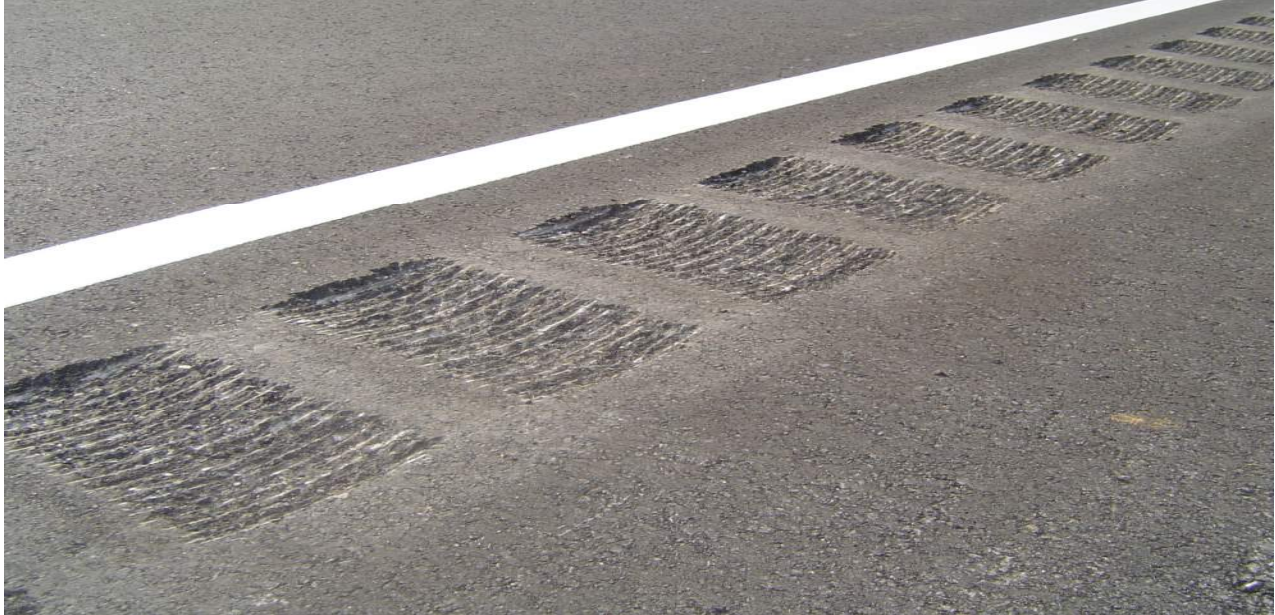
Figure 19 Typical Shoulder Rumble Strip

the construction of four foot wide or eight foot wide paved shoulders, or after the paved shoulders are constructed. Shoulder rumble strips, however, reduce the usable width of the shoulders that bicyclists could use. Exhibit 7 shows a schematic view and limits of the shoulder rumble strips, and Figure 19 shows a sample shoulder rumble strip.

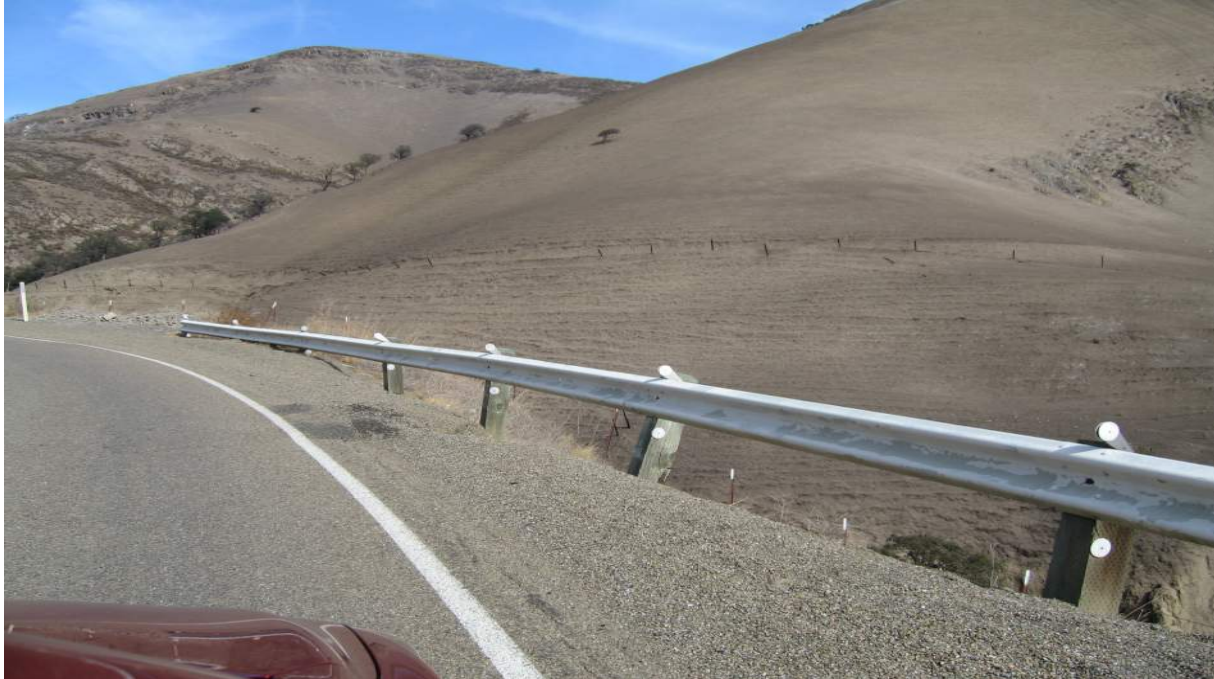
Figure 20 Example of guardrail replacement that requires re-grading of embankment

Guard rail has been installed at numerous locations along Tesla Road. At several locations along the roadway, existing guard rail does not meet current standards and needs to be replaced adjacent to a steep embankment. Replacing these existing guard rails at certain locations would involve a considerable amount of re-grading of the existing embankments, and thus would have a high construction cost due to the amount of grading required. Eight locations were identified for guard rail replacement in the mid-term, and these locations are shown in Exhibit 8.
